**INVESTIGATION OF  
BUSHFIRE ATTACK MECHANISMS  
RESULTING IN HOUSE LOSS IN THE  
ACT BUSHFIRE 2003**

**Bushfire CRC Report**

*Raphaelae Blanche and Justin Leonard*

**April 2005**

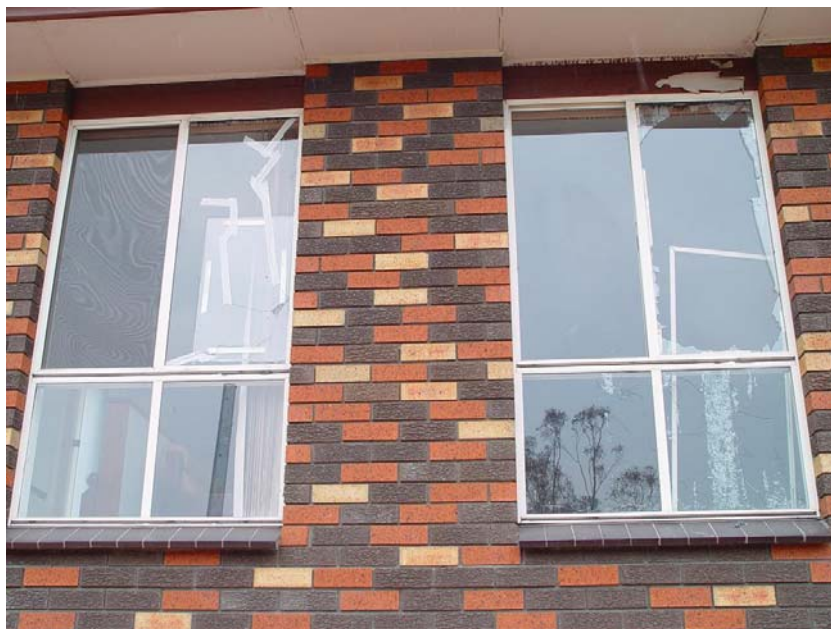
**Figure 9. Broken and cracked windows from radiant heat from neighbouring house and fences (73 Somerset St)**

The impact of radiant heat on a house not only supports the ignition of flammable material on the structure, but may also create openings by broking windows, which facilitates the entry of embers into the structure. The synergistic effect of these two mechanisms of attack increases the potential of house loss, especially if the ignited points are not extinguished quickly.

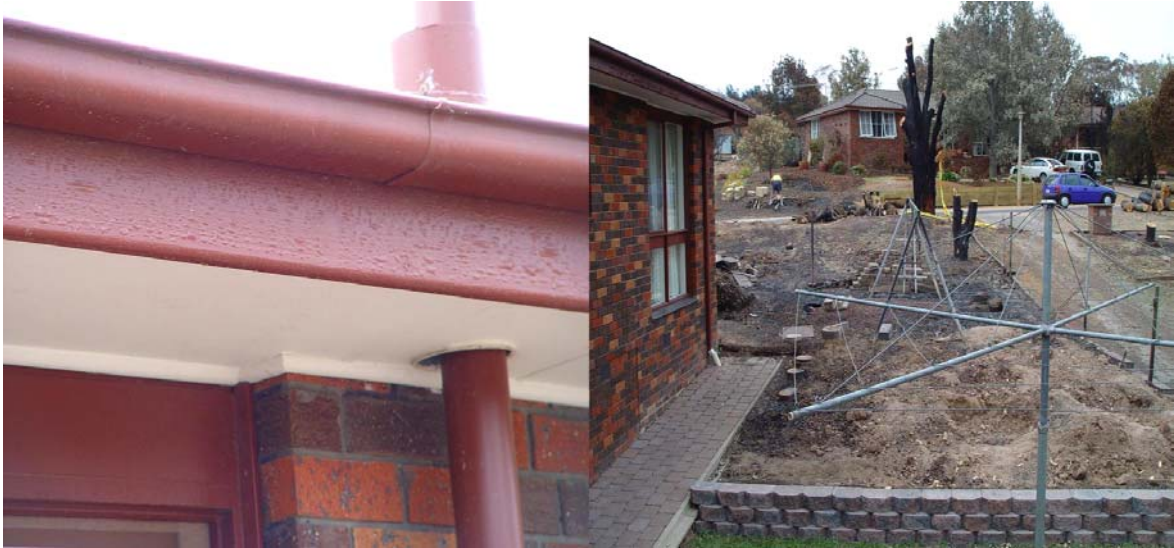
**Figure 10. Radiant heat impacts on eaves from surrounding vegetation  
(73 Somerset St)**

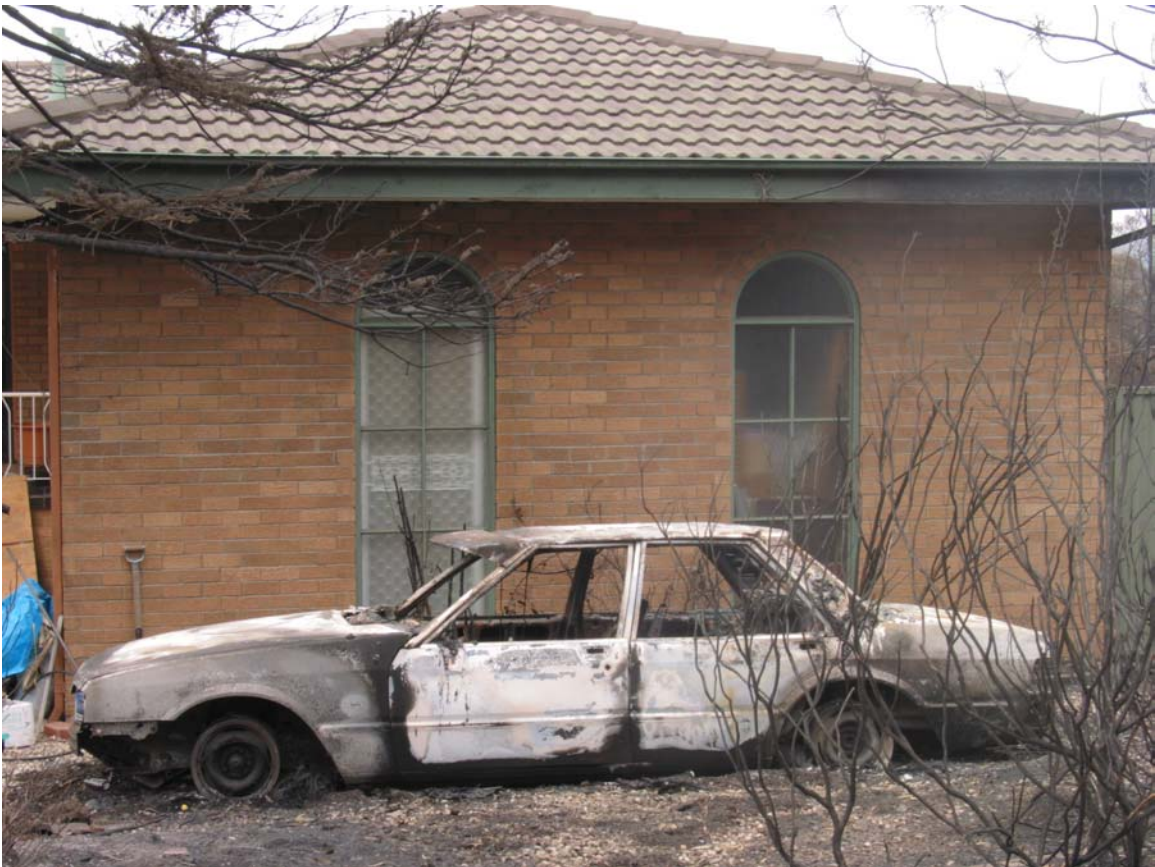
**Figure 11. Other example of radiant heat impact due to vegetation and car fire  
(86 Somerset St)**

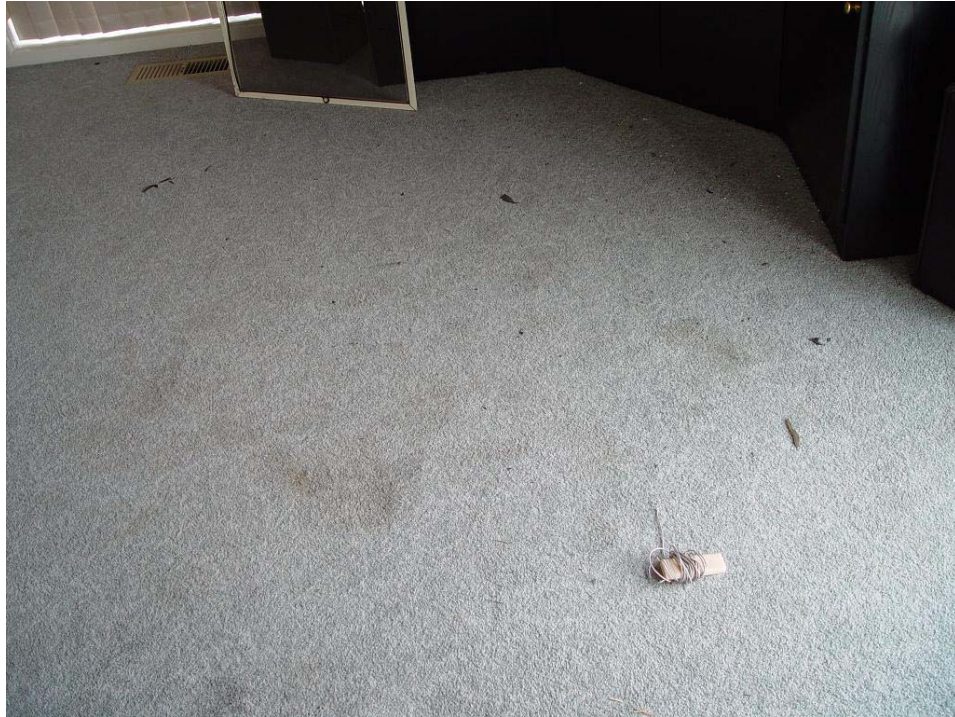
**Figure 12. Ember attack on carpet  
(73 Somerset St)**

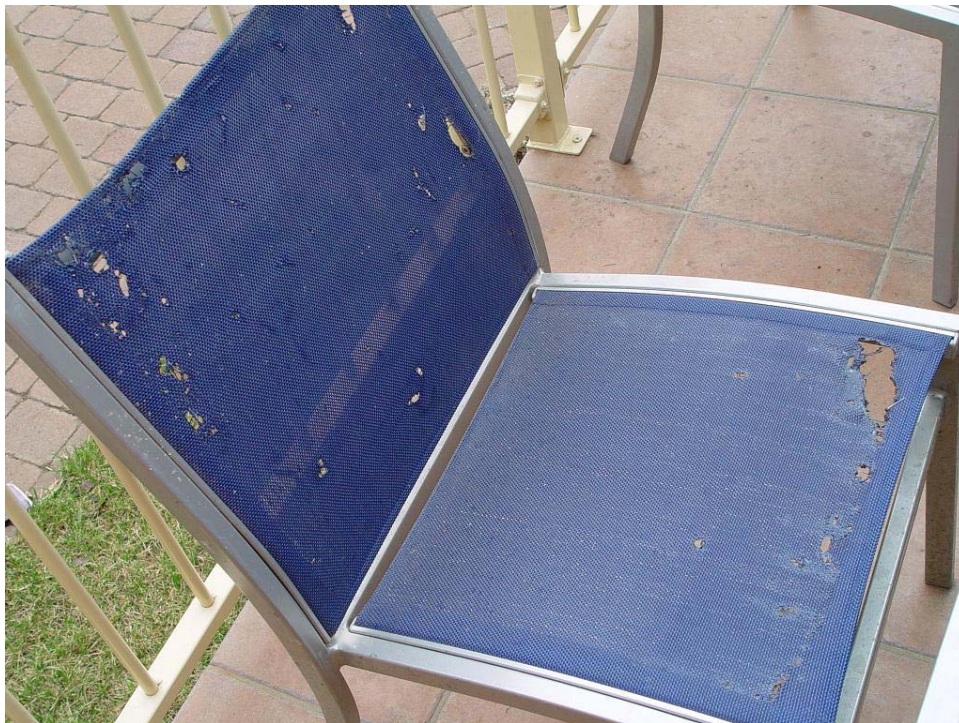
**Figure 13. Ember attack on chair on deck (73 Somerset St)**

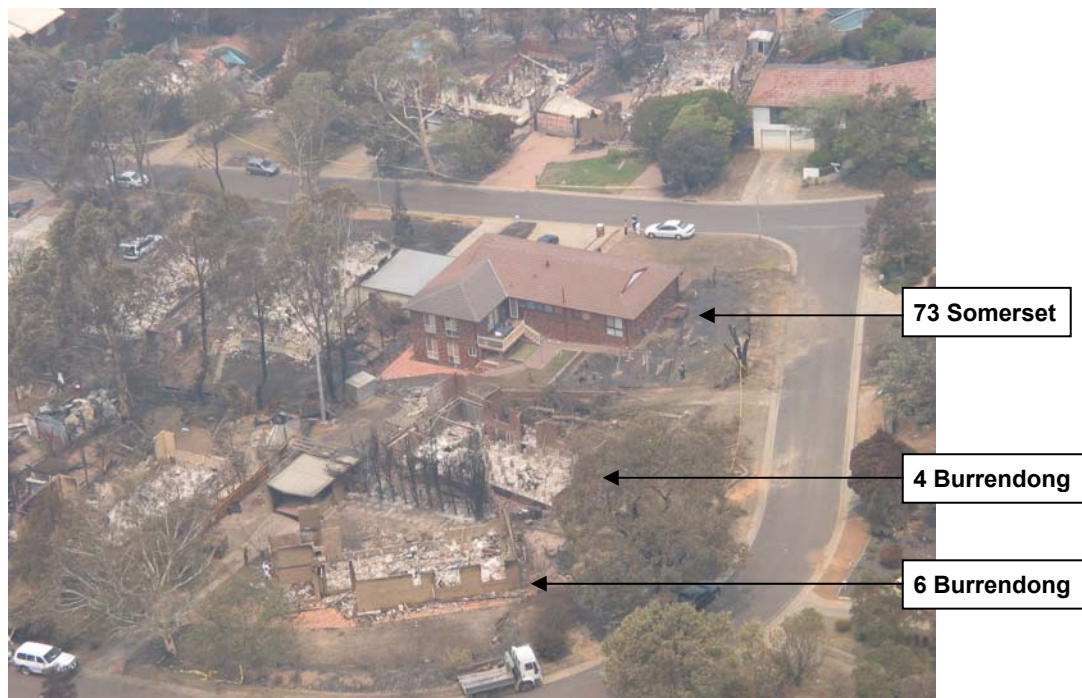
Figure 16. House-to-house fire spread involving cypress trees

An occupant of 73 Somerset St reported that, at a neighbouring house (4 Burrendong St), ‘embers igniting pencil pines and ignition started at the east back corner of the house, embers “plastering” under eaves, along fences, garden, mulch, bark all alight from embers, strong wind’.

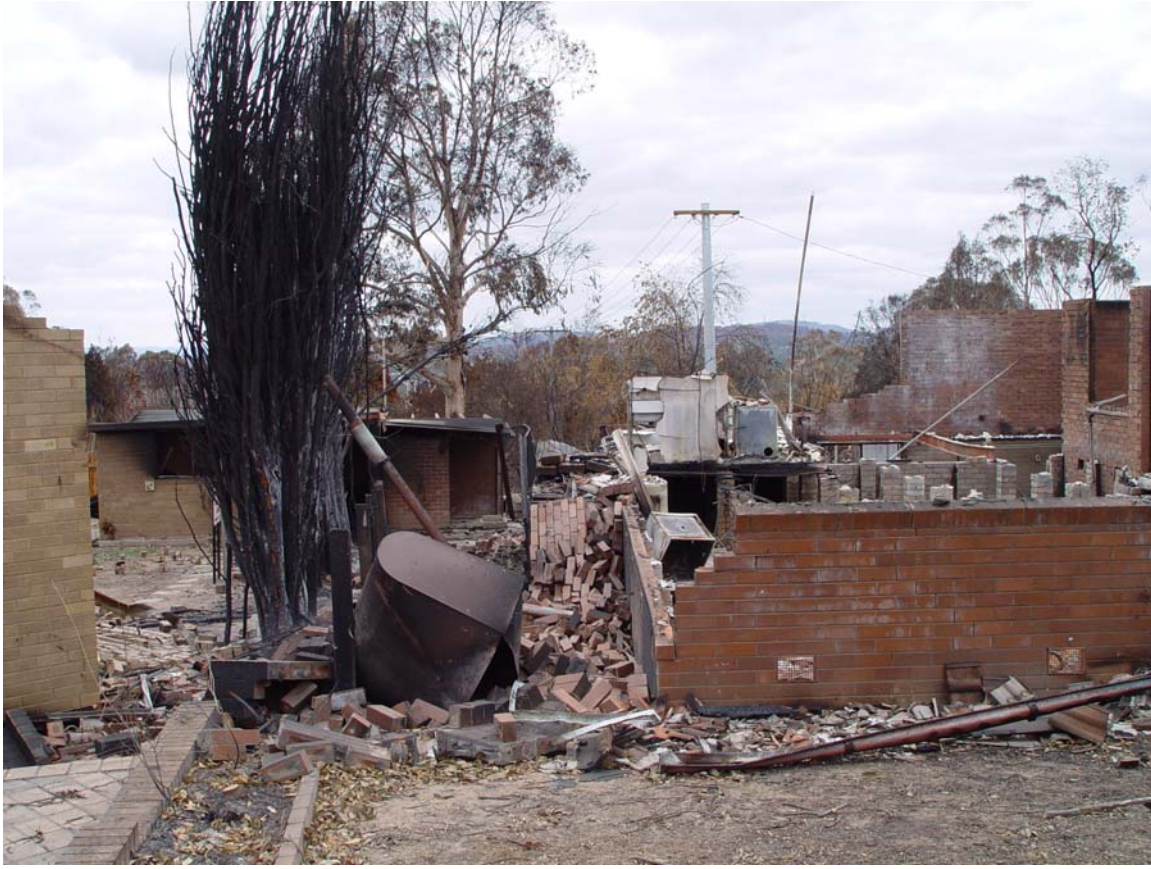
**Figure 17. Detail of pencil pine burn between 4 and 6 Burrendong St**

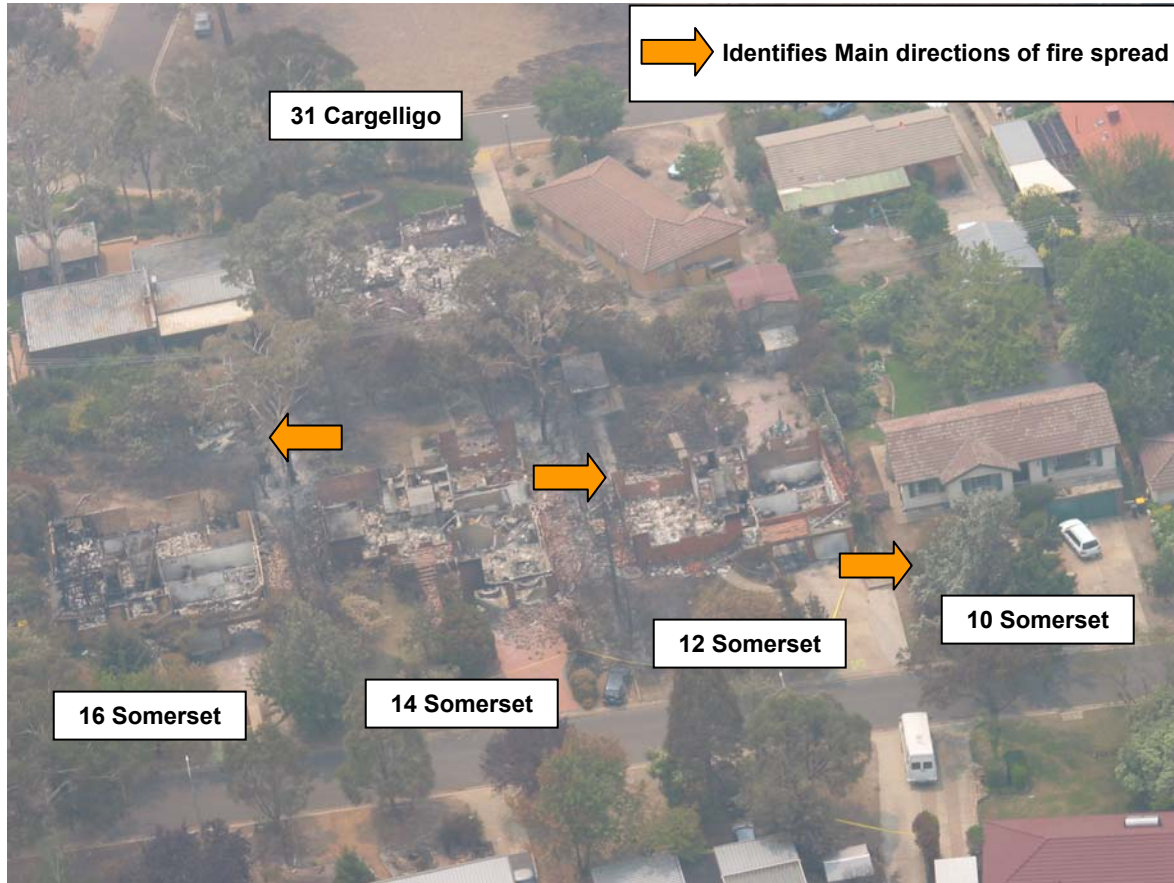
**Figure 18 Aerial photo of 12, 14, 16 Somerset St and 31 Cargelligo St (destroyed houses)**

These four destroyed houses were deep within the suburb and surrounded by surviving houses. It is highly likely that an ember attack ignited 31 Cargelligo St, which then become the predominant source of fire attack on the area of 14 Somerset St. House-to-house fire spread from 14 to 12 Somerset was reported during the survey, and ground-based photo evidence identifies that fire spread involving ground fuels and secondary elements between 14 to 16 Somerset, as well as from 31 Cargelligo to 16 Somerset. Figures 19 and 20 provide further visual evidence of these mechanisms. The occupant of 10 Somerset elected to stay, he mentioned that he was involved in extinguishment activities from ember attack and burning fences associated with the structural fire at 12 Somerset, these activities may have reduced the risk of further house ignitions.

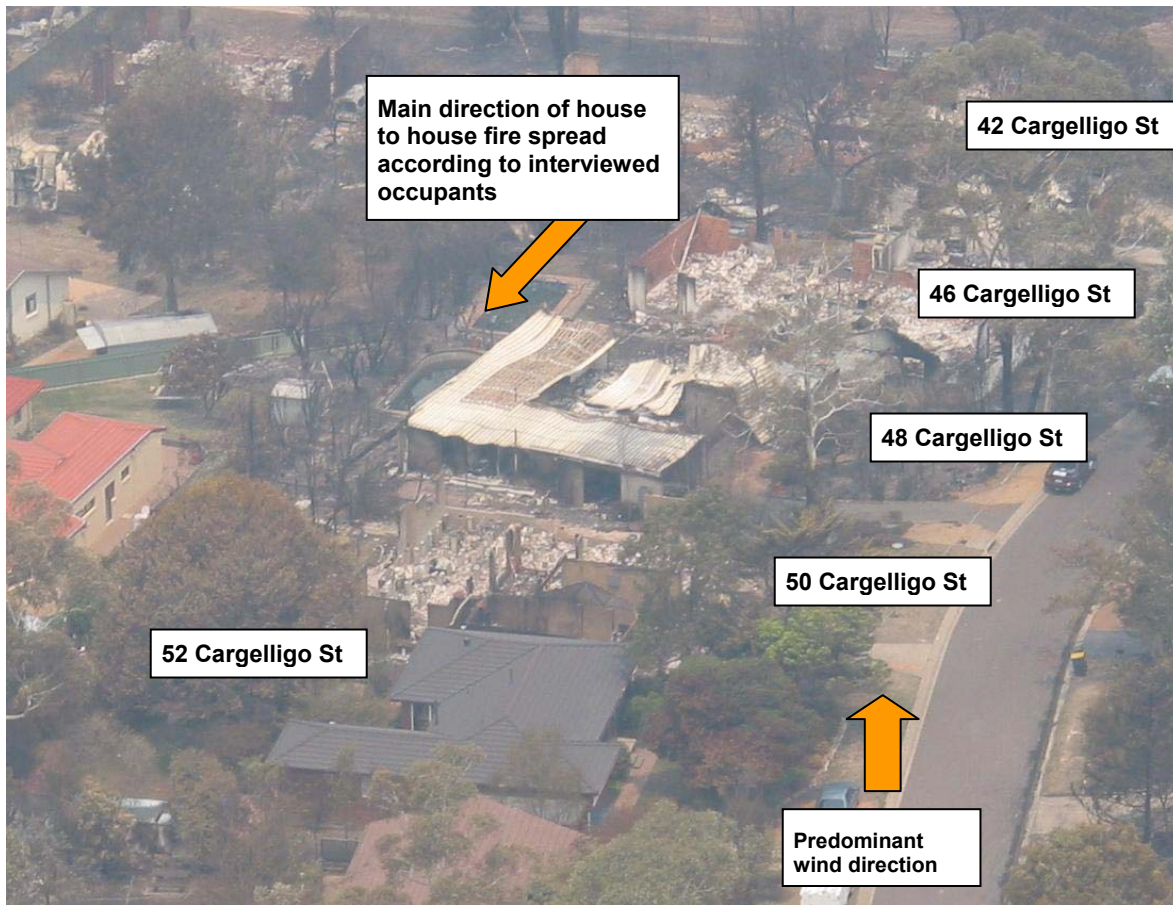
These four brick houses were destroyed by a fire that probably resulted from embers ignition. The occupant of 52 Cargelligo St identified that the fire started at 42 Cargelligo St and spread against the predominant wind direction to 46 then 48 then 50 until reached the house he was occupying at 52 Cargelligo St. Most other observed spread mechanisms are driven or heavily influenced by the prevailing wind direction.

Figure 21. Aerial photo of 46, 48, 50 and 52 Cargelligo St

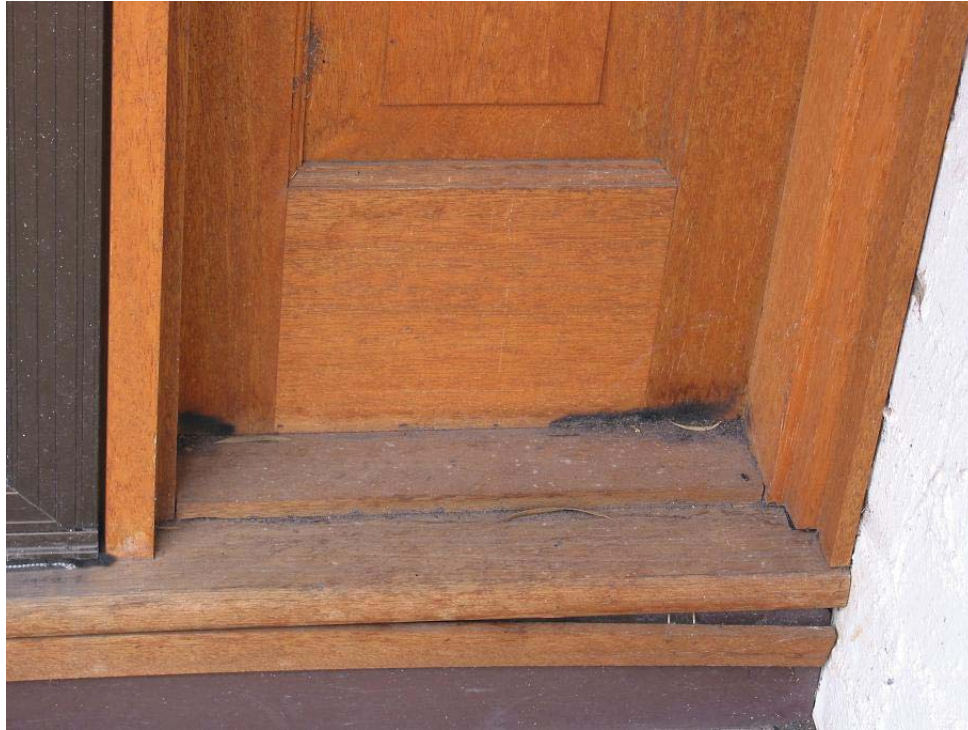
**Figure 23. Ember attack on a door (re-entrant corner)**

A method of reducing this effect is to either screen the door with a non-combustible screen door or use low- or non-combustible materials in the door assembly. The data collected in Duffy suggests some correlation between protected door openings and house survivability; however, this correlation is far from conclusive due to the large percentage of destroyed houses for which door protection was not determined (refer Figure 24). An important point to also make is that these screen doors are only effective if they are closed before, during and after the fire event.

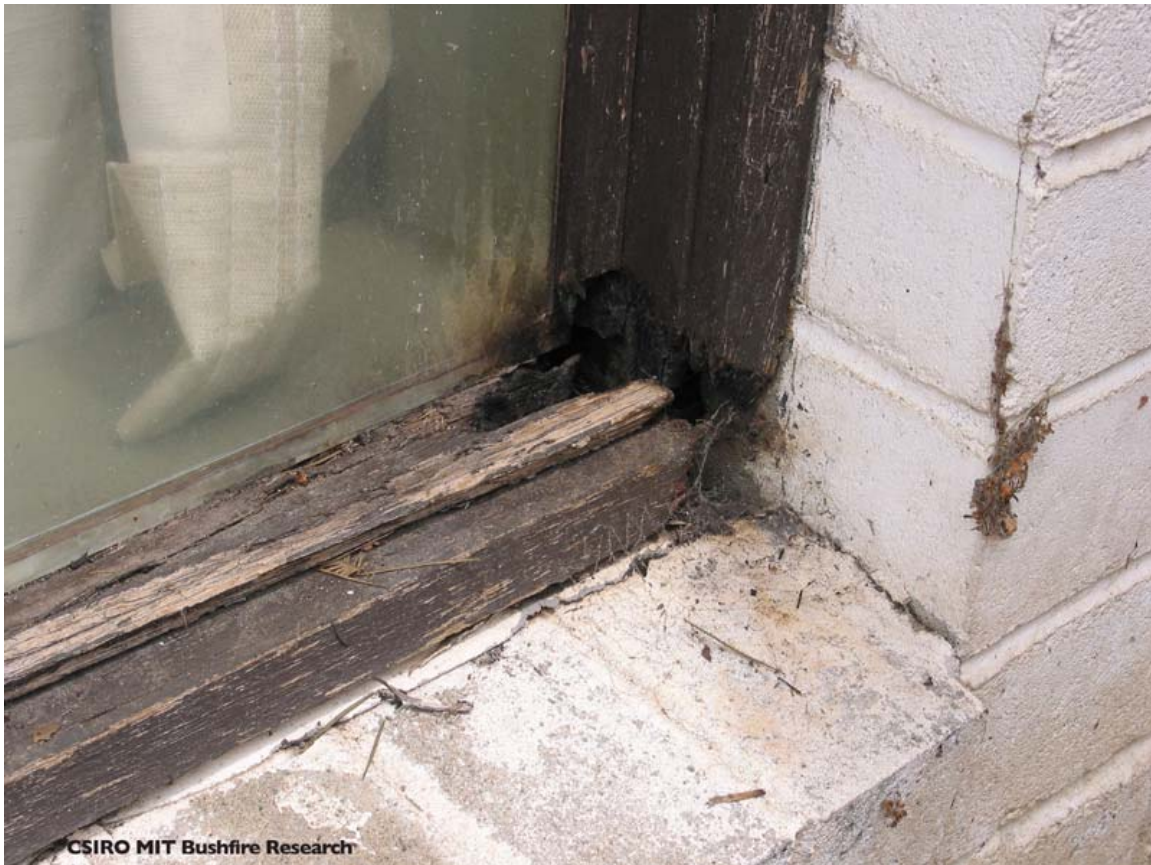
Figure 25. Ember attack at a re-entrant corner

The poor condition of some timber windows could further increase ignitability (see Figure 25).

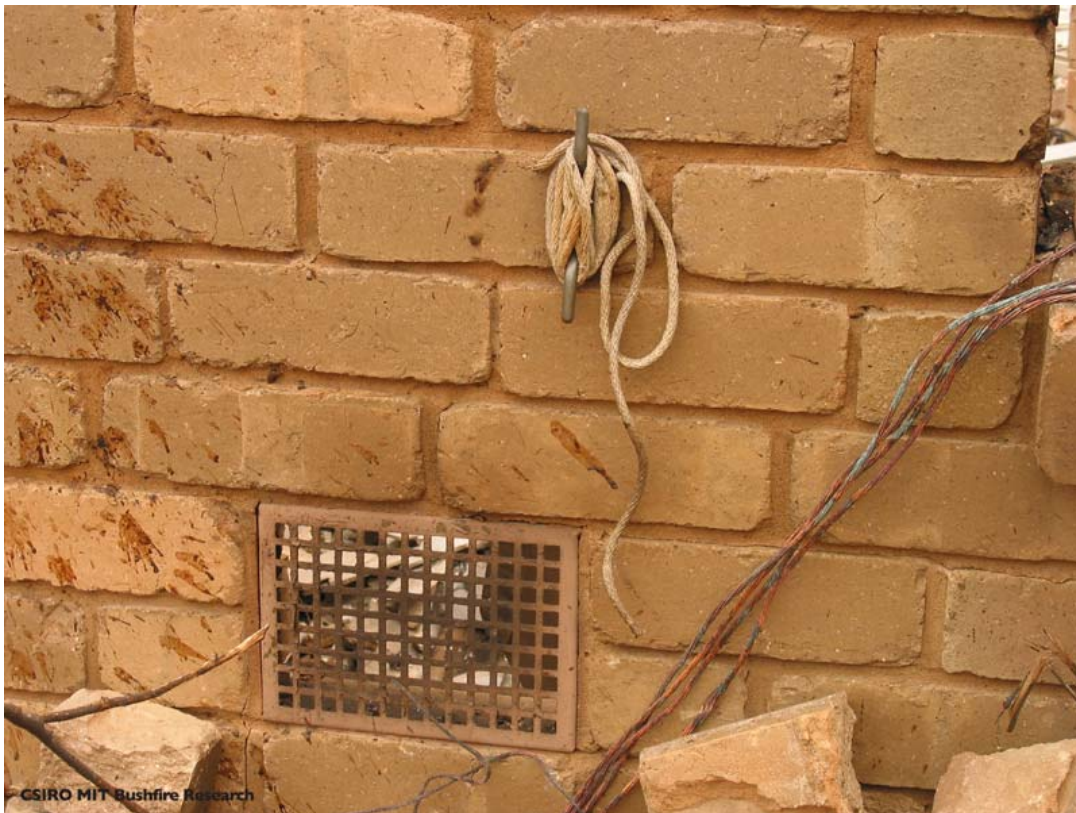
An example of an unprotected vent in a house surveyed in Duffy is shown in Figure 31.

**Figure 31. Typical unprotected vent**

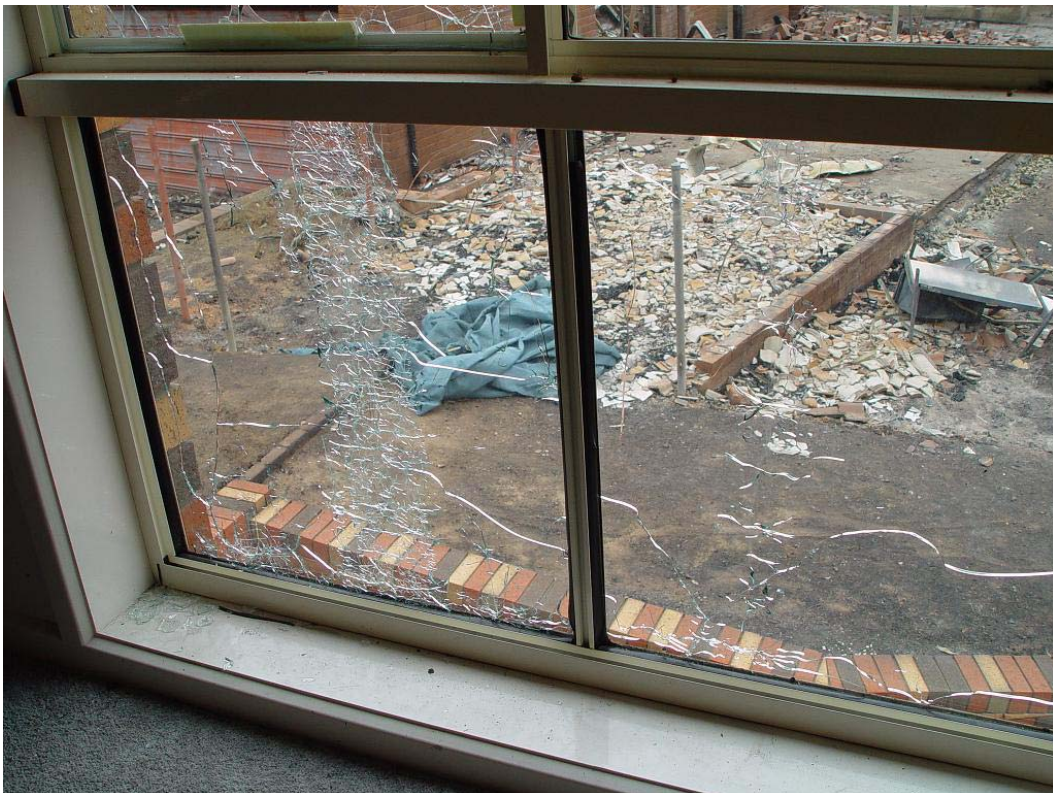
**Figure 34. Damage to laminated glass**

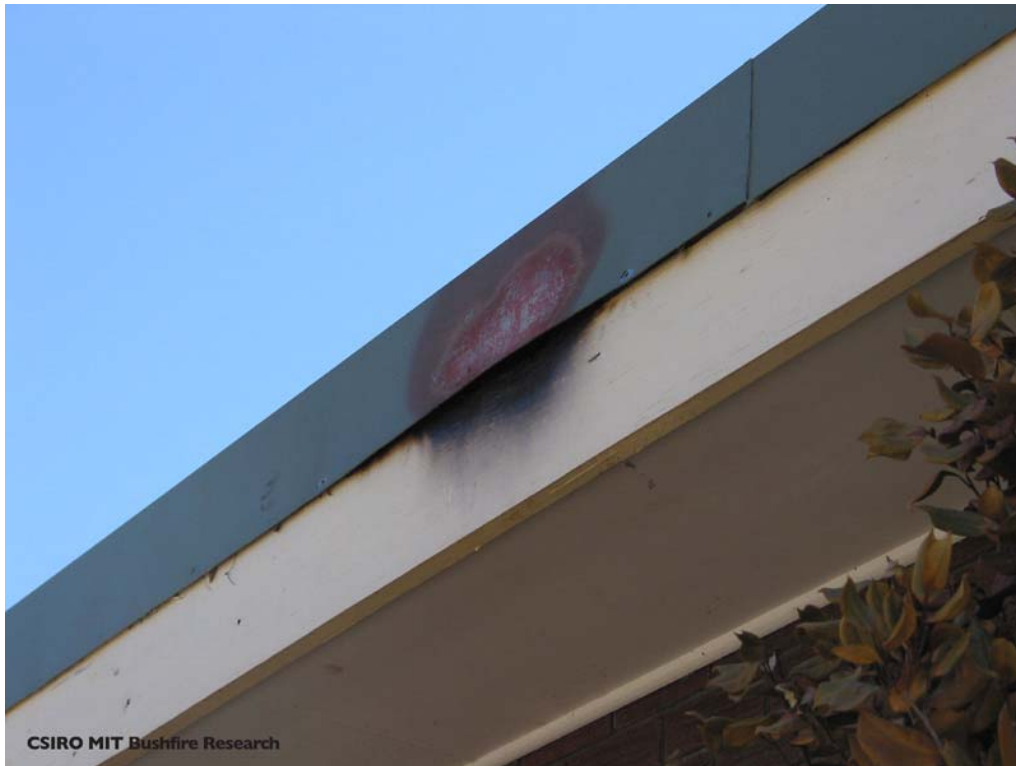
**Figure 35. Ember attack on poor fitting capping**

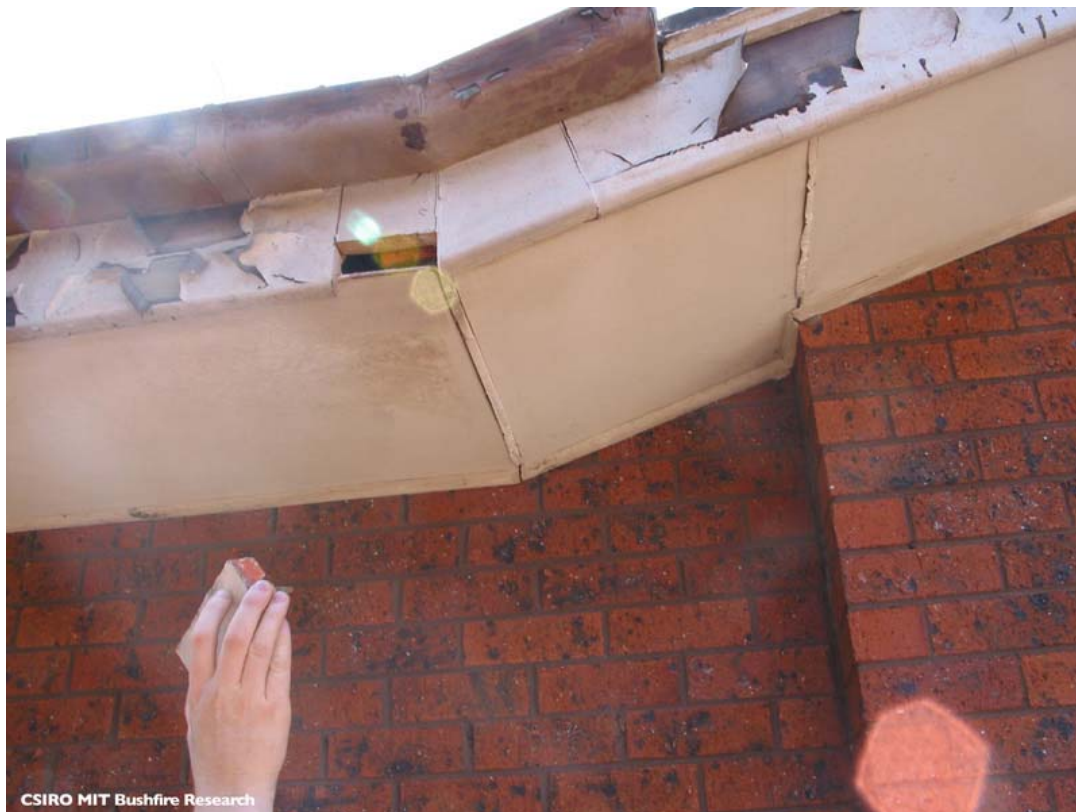
**Figure 36. Eaves damage due to radiant heat from adjacent fence and vegetation**

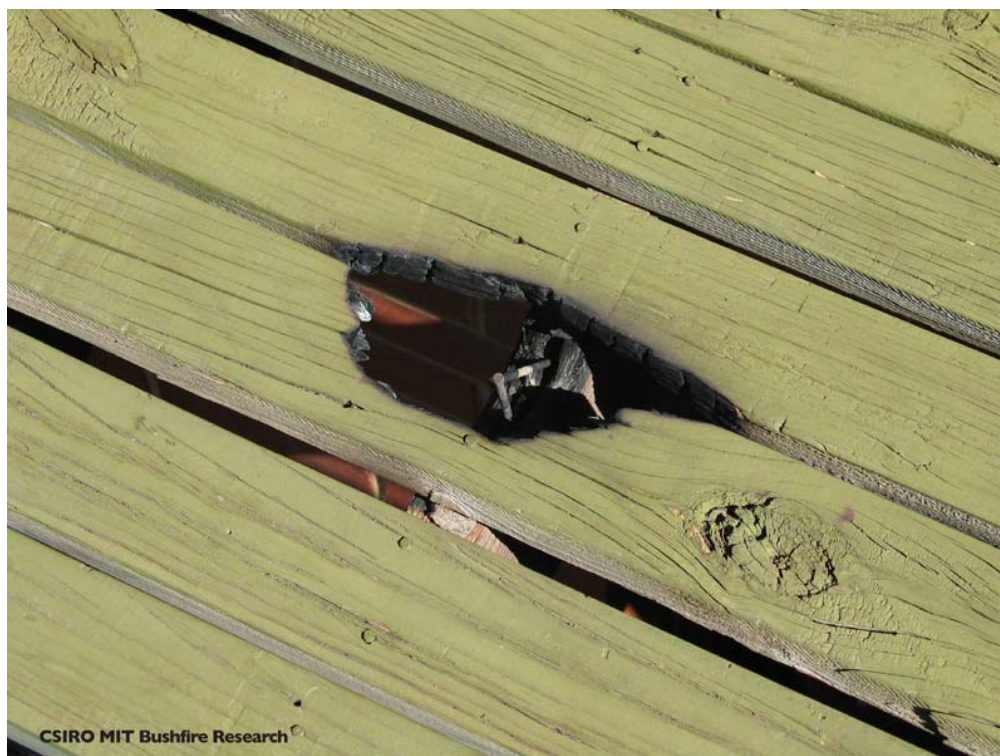
Of the houses in the surveyed area, 69% either had no deck or had non-combustible decks (Figure 37). A number of examples of timber deck ignitions that were suppressed by occupant activity were noted in the survey (see Figure 38).

**Figure 38. Ember attack on deck (with intervention)**

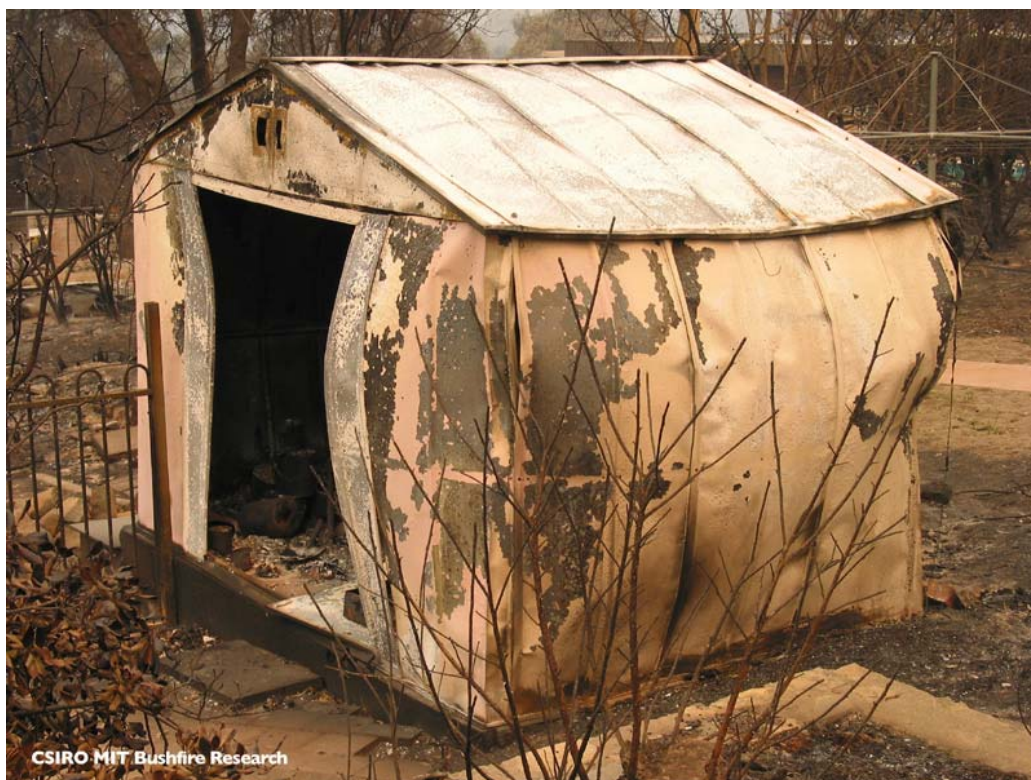
**Figure 41. Shed fire damage**

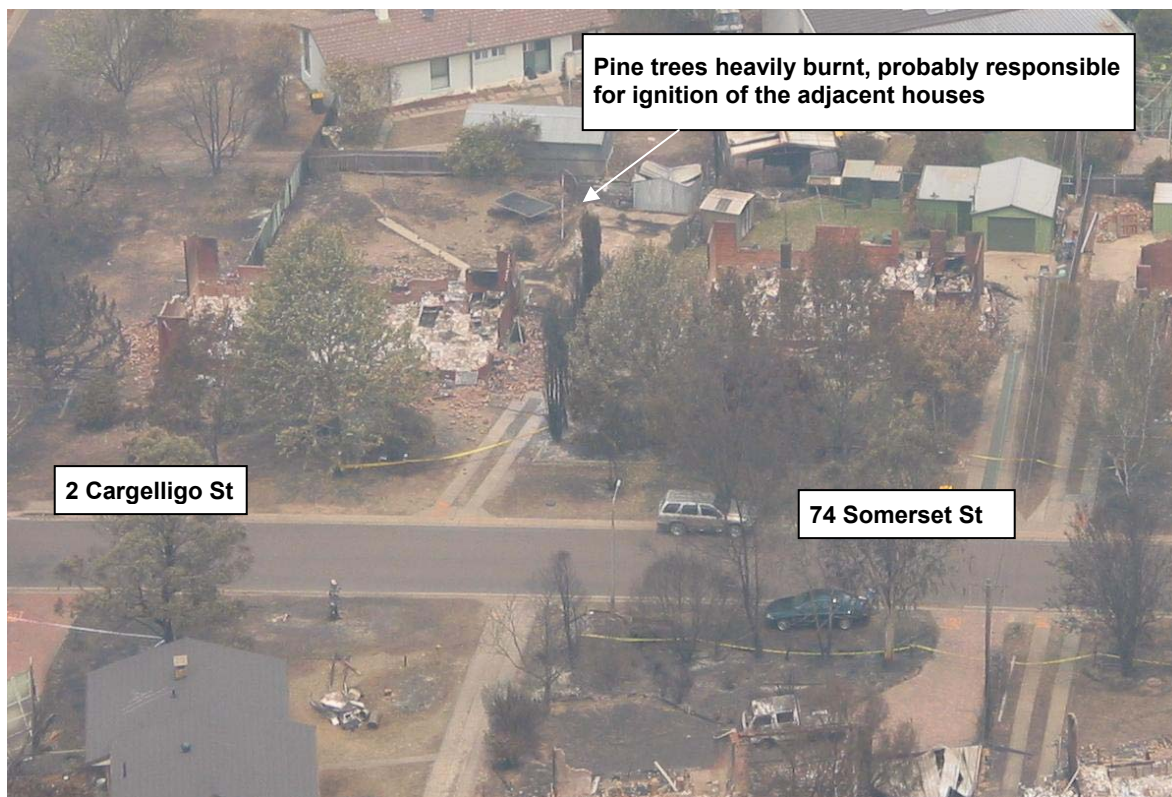
**Figure 43. Pines fence responsible for ignition of 74 Somerset and 2 Cargelligo St**

The extensive row of pine trees between 74 Somerset St and 2 Cargelligo St (see Figure 43) were most likely ignited by ember attack from houses on the other side of the road. The combustion of this kind of pine tree presents a very high risk from radiant heat and embers to the adjacent houses. This situation is exacerbated by windows facing these pencil pines. This observation is emphasised by the fact that the aerial picture (Figure 43) shows no other ignition in the vegetation in front of the house (unburnt trees).

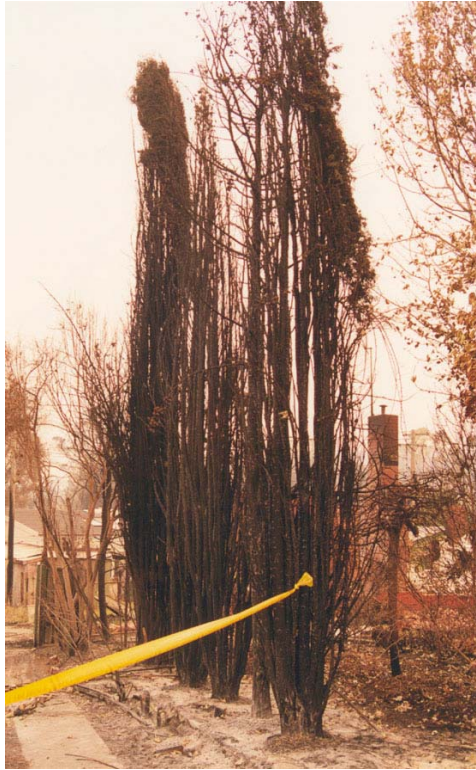
**Figure 44. Pencil pine trees heavily burnt (fence between 74 Somerset and 2 Cargelligo St)**

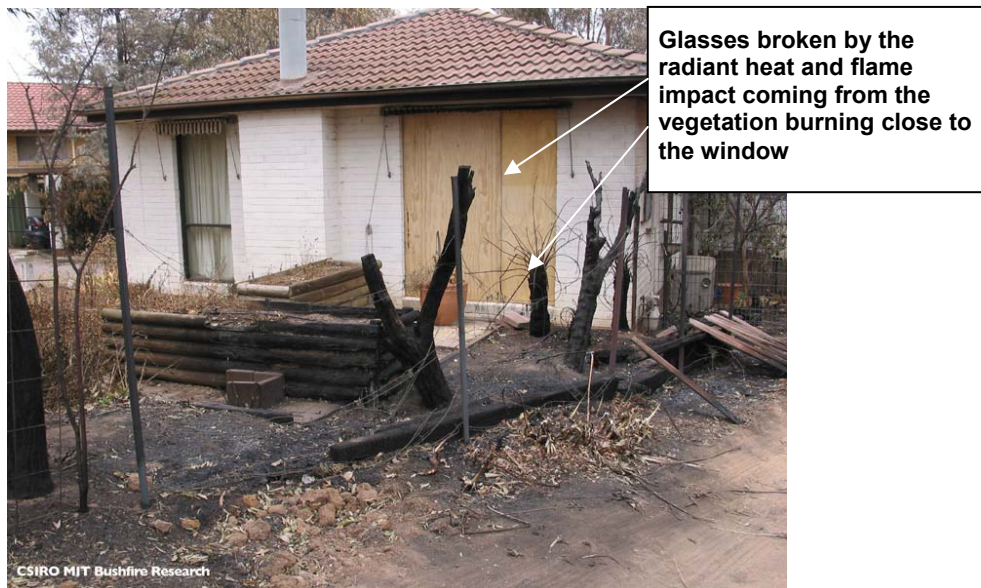
Figure 45 shows another example of how the proximity of vegetation provides direct flame and radiation attack on the main structure. In this case, the window was broken during the attack and a gas meter positioned at the corner of the structure provided further impact on the windows and eaves. This structure was defended by occupants during the fire event. Further discussion on gas meter performance can be found in Section 8.3.

**Figure 45. Local fuel impact on a structure**

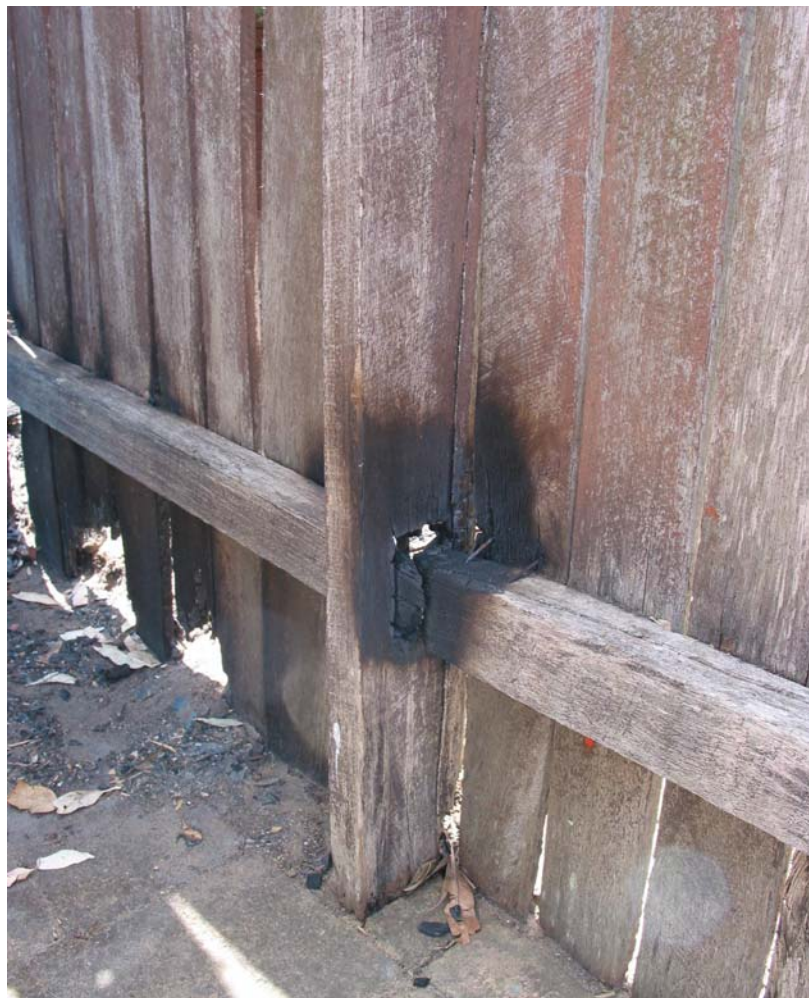
**Figure 46. Ember attack on fence (with intervention)**

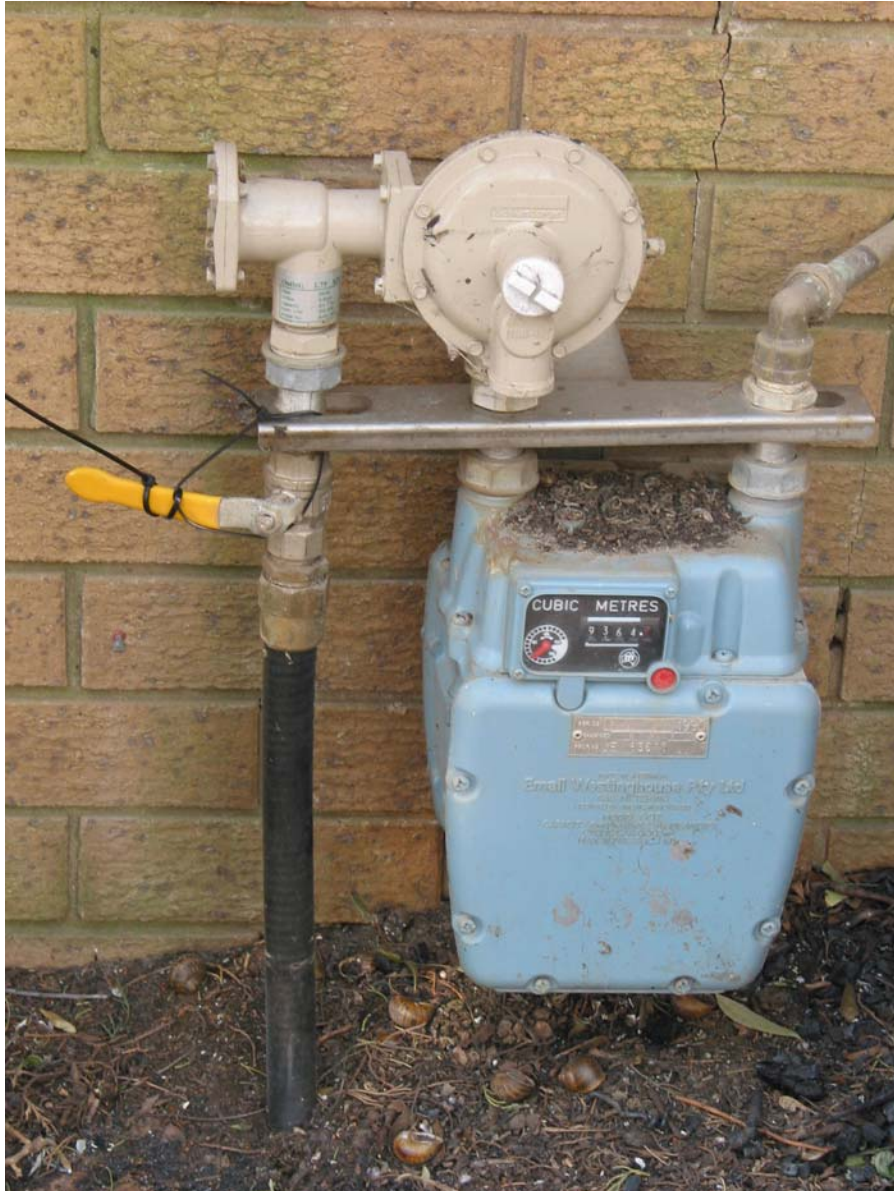
In a number of cases, these flexible lines ruptured after receiving low-level flame contact. The presence of a burning gas plume adjacent to a structure represented a significant risk to the structure. AS 3959 requires all pipe infrastructure supplying a dwelling with essential services utilise non-combustible piping. Figure 49 provides a visual example of how this mode of attack affects a residential structure.

**Figure 48. Flexible gas line supply to gas meter**

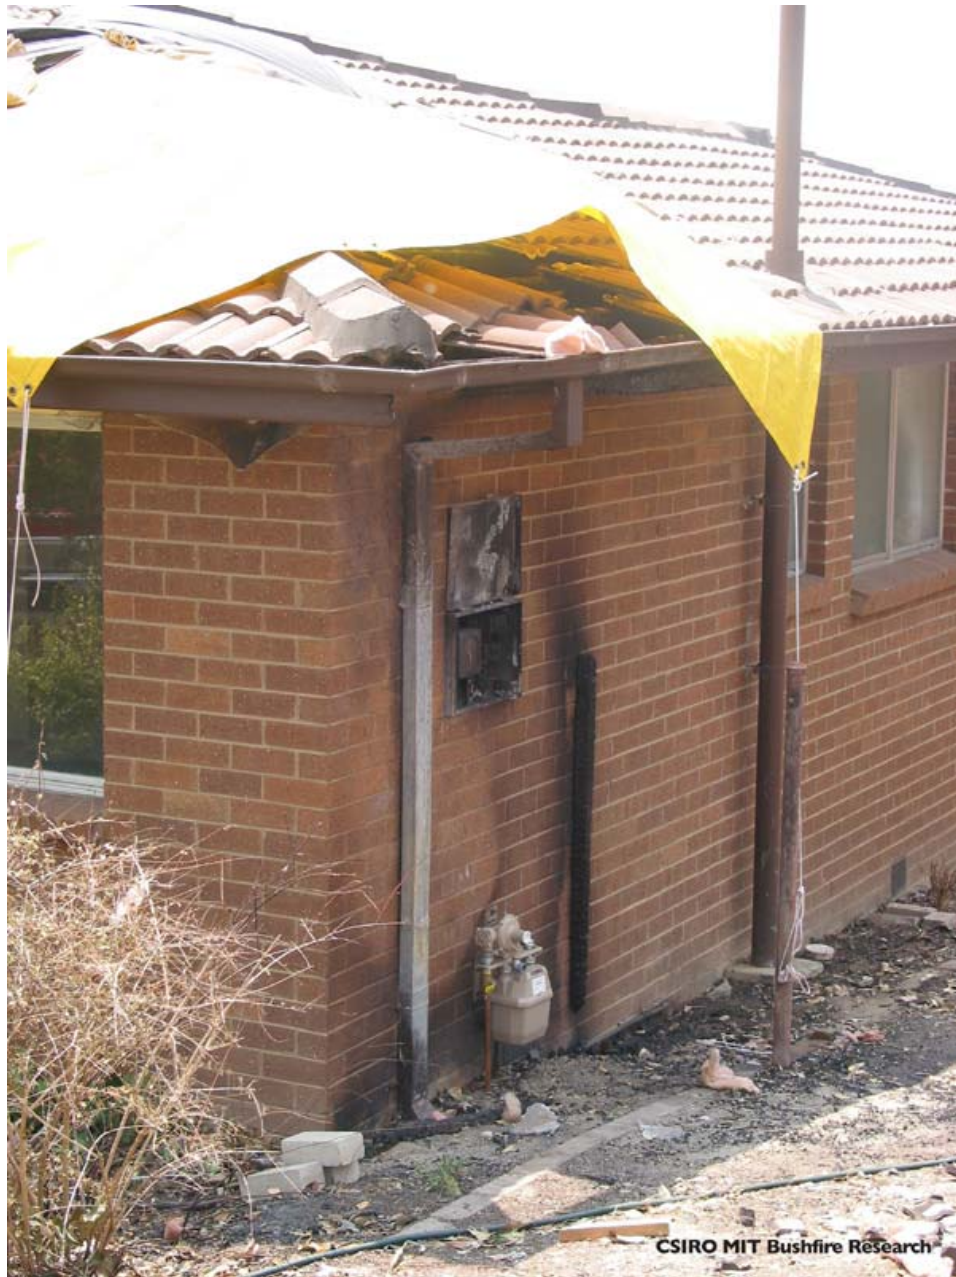
**Figure 49. Gas meter flaring attack on eaves**

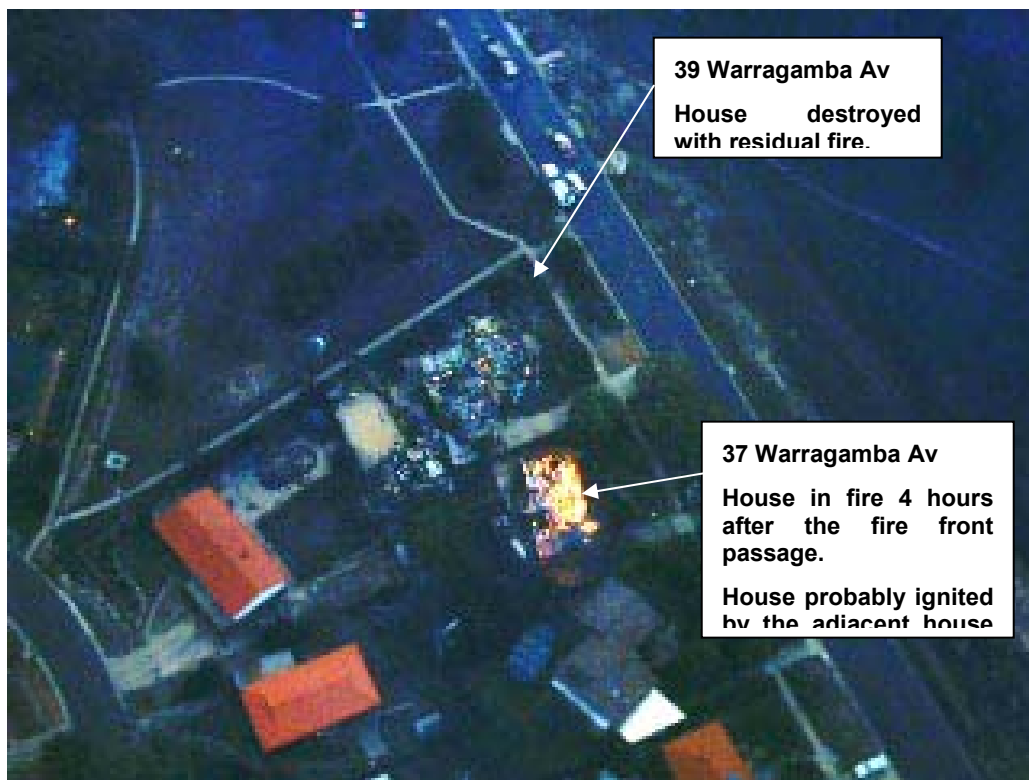
An Aerial photo showing number 37, 39 Warragamba Av was taken at 7:09 pm on the 18<sup>th</sup> of January, see Figure 52. This photo identifies that the houses at 39 Warragamba Avenue was reduced to smouldering rubble at this time, while the house at 37 Warragamba Ave was burning vigorously. This provides an important example of how 37 Warragamba Avenue burnt down well after the main fire event. 37 Warragamba Avenue was most likely ignited by radiation and flame impact from the adjacent house fire at 39 Warragamba Avenue.

Figure 52 Aerial picture of 37 and 39 Warragamba Av taken at 7:09 pm ( Photo kindly provide by Steve Wilkes )
