# Tropical Cyclone Narelle: Insights on resilience

Understanding damage, vulnerabilities and future risk to buildings in Wind Regions D, C, B2 and A

**A/Prof Geoff Boughton<sup>1</sup>, Dr David Henderson<sup>1</sup>, Simon Ingham<sup>1</sup>, Dr Bruce Harper<sup>2</sup>**

Natural Hazards Research Australia  
ISBN: 978-1-923057-72-2  
Report number: 89.2026  
June 2026

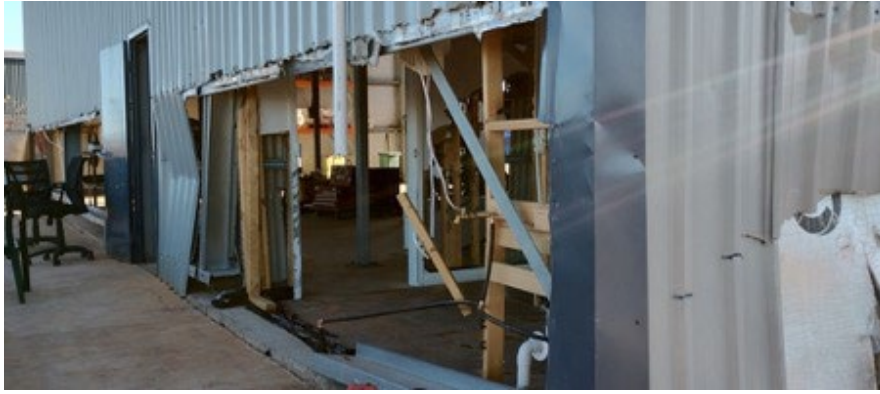
There were significant storm tide effects in Exmouth Gulf. They were a combination of storm tide and wave action. The data from the tide gauge at Exmouth showed that the storm tide there was 3 metres. This correlated well with the modelling from SEAtide which is shown below. It indicates that storm tide peaked at 3 metres Australian Height Datum (AHD) and at the same time the most significant waves in the Gulf were around 3.8 metres. The combination of wave action and storm tide height broke over the sea wall at the Exmouth Marina. This damaged the sea wall and several buildings.

Wave and storm tide damage to a building at Exmouth wharf

It is difficult to design buildings to resist waves on top of storm tide. Rather than building to resist wave action, it is better to avoid building in storm tide risk areas. Because of the risk to life of storm tide actions on occupied buildings, all buildings in storm tide areas should be evacuated.

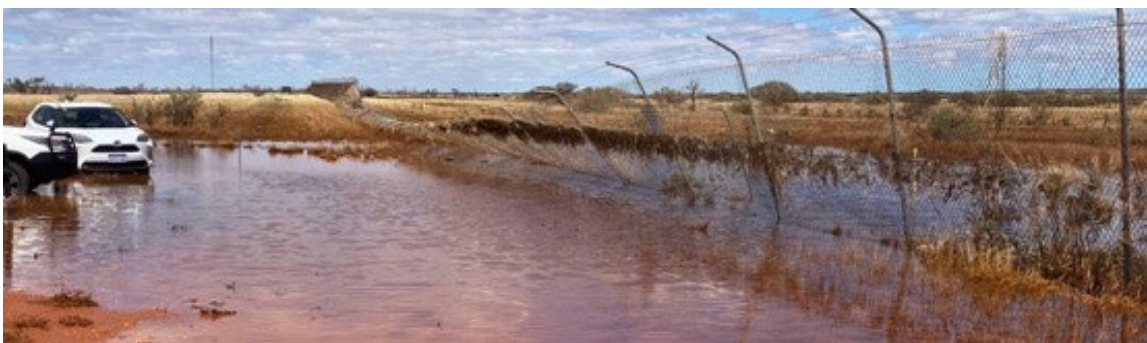
A combination of wave action and a higher storm tide further south in the Gulf near Learmonth caused the water to overtop the dunes and break into the land near Learmonth airport. The water washed over the runway, taxiways and carparks and damaged the road between Exmouth and Learmonth. Having travelled over 2 kilometres inland to reach the airport, the effects of waves were minimal. Damage caused by storm tide at the airport was due to inundation. Storm tide did not damage the airport terminal.

Storm tide mark on fence and damage in a carpark at Learmonth airport

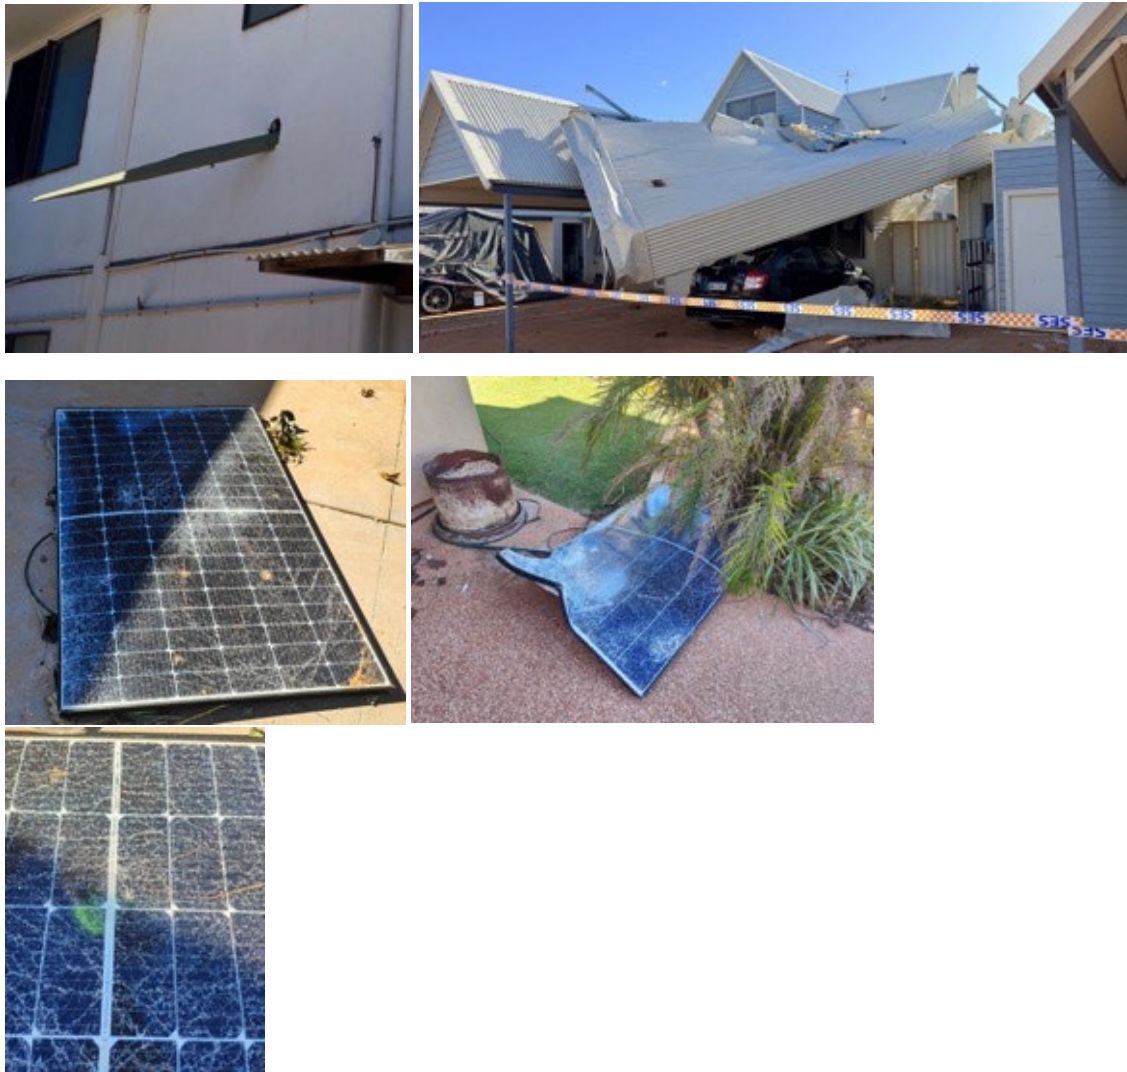
Windborne debris in Exmouth, piece of timber, section of complete roof, solar panels

Screens and debris protection that can absorb the energy of a piece of timber cannot protect against heavier items such as portions of a roof or solar panels shown in the Figure above. The only effective way of preventing roof loss after a debris strike is to design the building to be able to cope with the high internal pressure following creation of a large opening by wind-borne debris.

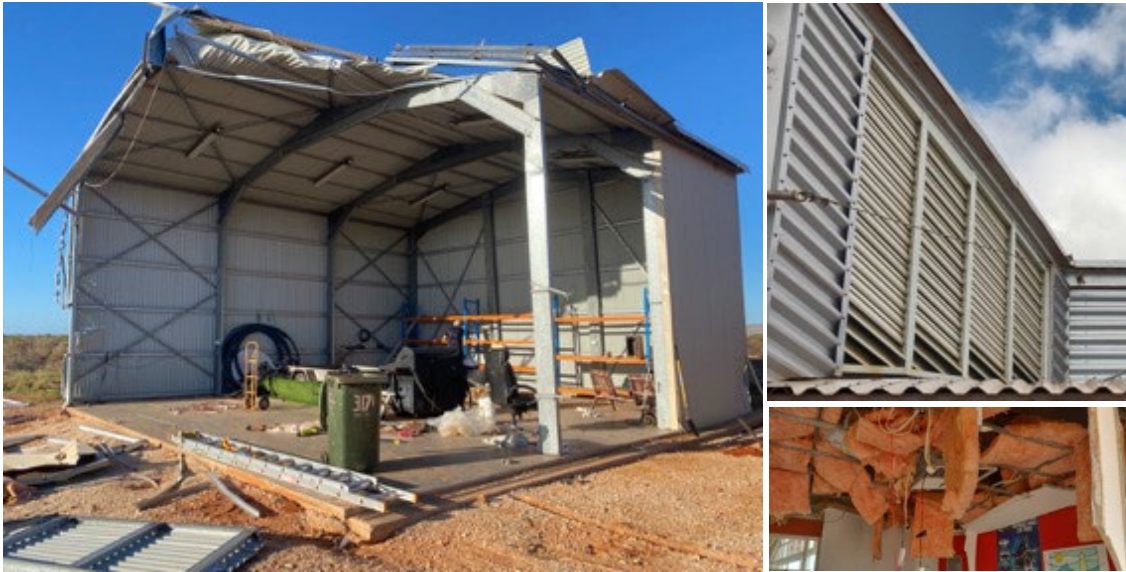
A large, enclosed shed lost two sliding doors off one side when the wind was blowing parallel to the ridge, and the doors were sucked out by the sidewall negative pressure. After the wind direction changed by 90°, the very large opening was on the windward wall, and the internal pressure damaged the roof and blew out the ends of the building. It is shown below in the left photo.

The right photos below show a building in which the vent shown allowed pressurisation of the roof space above the ceiling and this positive pressure above the ceiling caused it to be pushed into the building.

Damage following internal pressure

All structures in the cyclone regions (B2, C and D) including sheds need to be designed to resist high internal pressures.

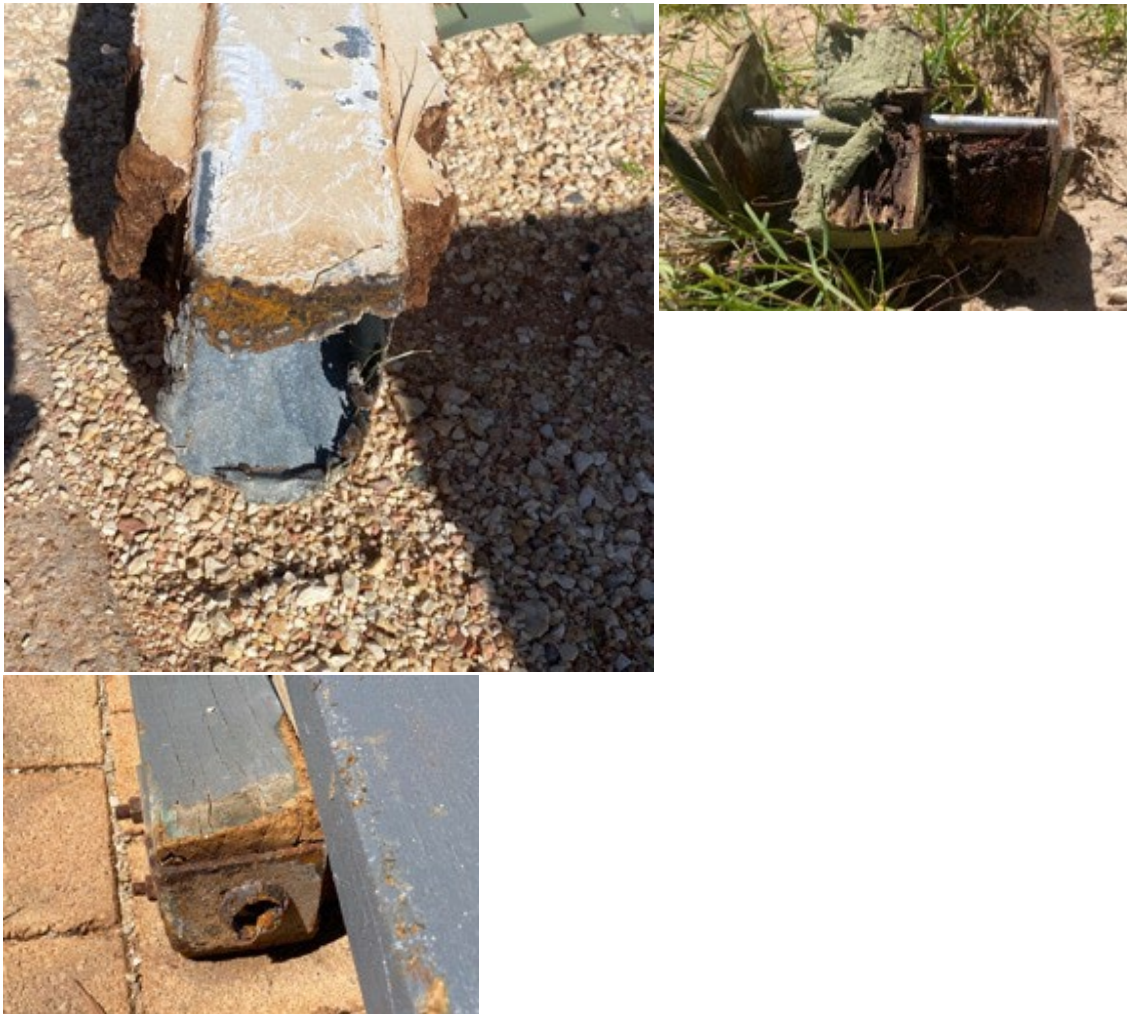
The inspection investigated 12 buildings in which verandas had failed. In nearly all cases, the reason for the failure when the wind loads were around 50% of the design wind loads for the region was deterioration of connections or the veranda posts.

Deterioration of metal components at ground level was common. Metal posts corroded where they contacted either the ground or concrete. Some timber posts supported on stirrups also failed because of either rot in the timber or corrosion of the stirrup. Loss of the integrity of the posts enabled the whole veranda to fold back at the eaves line. This damaged the wall and the roof behind the veranda. Where the veranda completely separated from the house, it became significant wind-borne debris. The following photo shows ground-line elements of verandas that had deteriorated.

Deterioration of veranda posts at ground line that led to veranda loss

All structural elements in verandas are exposed to the elements so resilience can be improved by selecting the appropriate corrosion resistance levels for metal elements in verandas. Continued maintenance should include replacing elements that have corroded or rotted. Painting elements that have been compromised by loss of competent material to corrosion or rot will not restore their structural function.

Functionality of buildings may be compromised if all elements of the building including verandas are not in good condition. Replace any elements that have deteriorated. Undertake more frequent maintenance of tie downs in coastal environments.

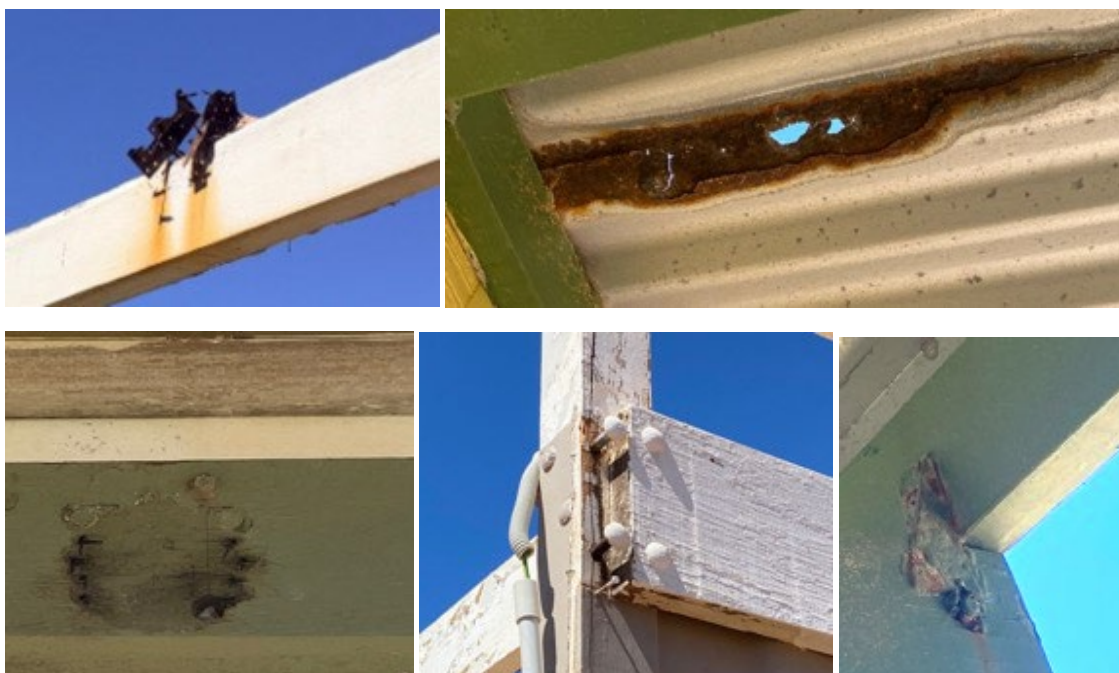
Deterioration of connections in the veranda also caused damage to the veranda with creation of more debris. Corrosion of connections within the veranda are illustrated below.

In coastal areas, specify all exposed fasteners including cladding fasteners and connections to roof-mounted attachments with appropriate corrosion protection for their environment.

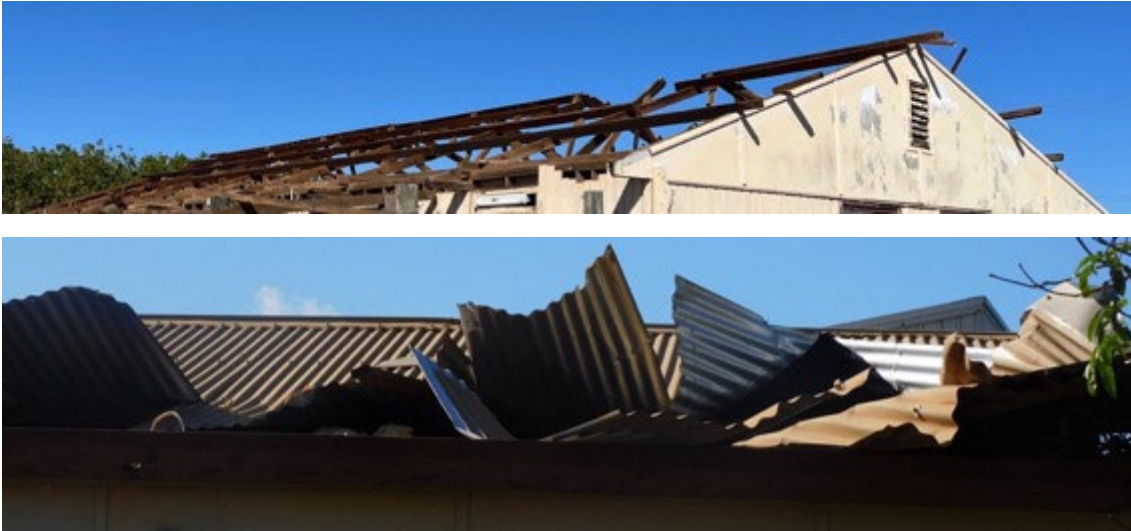
Roof damage was observed on some new buildings and some older buildings. The wind actions in Regions C and D were around 50% or less of the design wind actions. Damage in these areas was caused by:

- deterioration of roof fixings
- use of nails in batten to rafter connections
- errors in installation of roof tie downs
- poor fastening of flashings.

Roof damage to older buildings

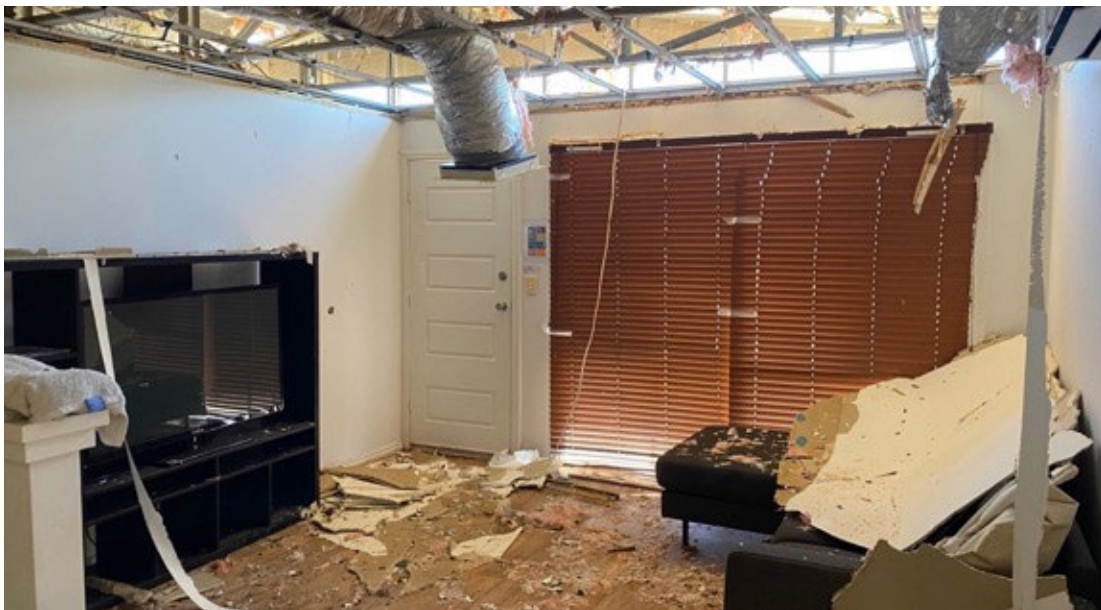
Where flashings had lifted or were ineffective, water had direct access to the roof space. Likewise, where verandas had been lost, the fascia or the roof was damaged. This allowed water into the roof space. In these cases, ceilings collapsed onto building contents as shown below.

Ceiling loss following damage to a veranda

Relatively minor levels of cladding damage produced significant levels of ceiling loss. The photo above shows ceiling loss over nearly the whole room after a fascia had been removed during the loss of a veranda.

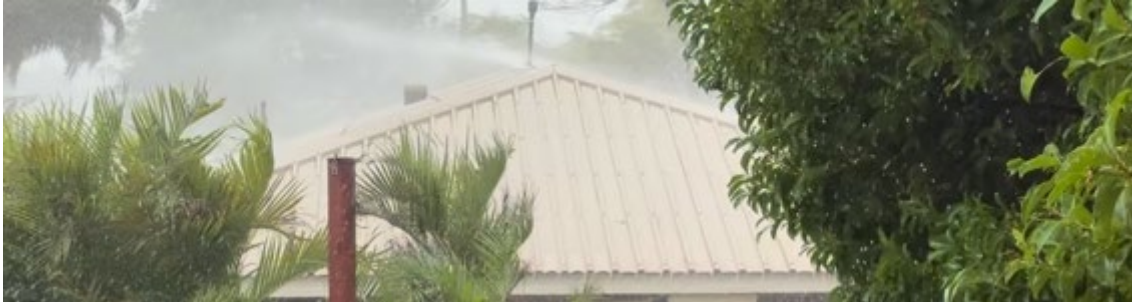
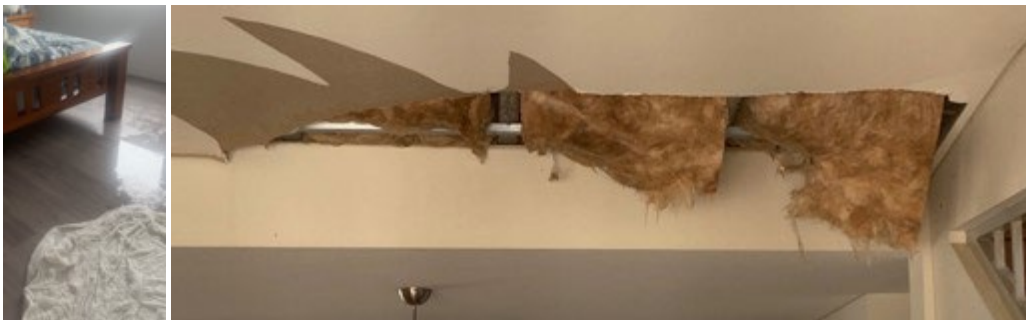
In addition to water entering the roof space where there had been some damage to cladding, water entered the roof space through the roof as wind-driven rain being forced under flashings or through minor gaps in the roof cladding. This included wind forcing water up box gutters away from the rain head or up valley gutters to enter the roof space at the top of the valley. The photos below show rain being blown over the top of a roof, water falling freely from the ceiling under a valley gutter and ceiling loss under a box gutter.

Rainwater passing up a roof slope, water falling from the top of a valley gutter and ceiling loss under a box gutter

Apron flashings, box gutters and valley gutters are all potential sources of wind-driven rainwater entry above the ceiling. If they cannot be avoided, they should be well sealed to prevent water from being blown over the edge of the gutter up under the roof. Profiled closed cell foam can assist in sealing these under the roof sheeting.

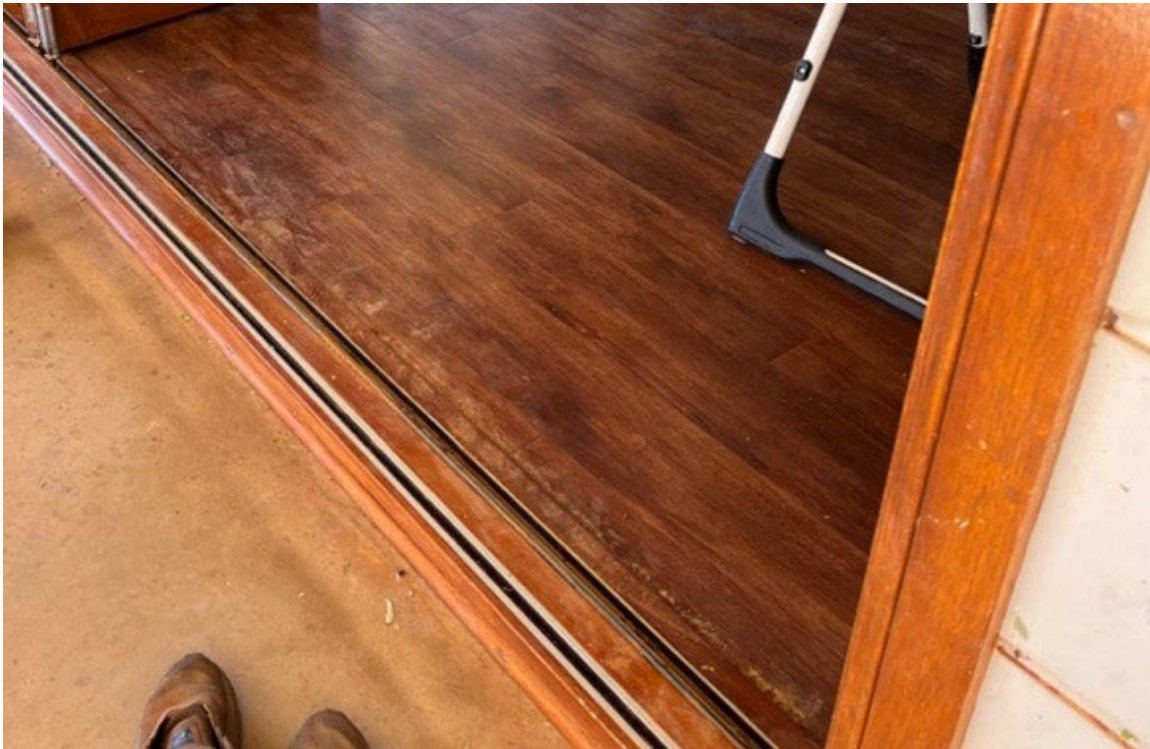
Water can also enter through window seals, and through gaps around moving parts.

Significant volumes of water came under this bifold door as there was no seal

Windows and glass doors that do not comply with current Australian Standards are too flexible to keep out wind-driven rain. Even those that do comply with Australian Standards offer more effective prevention of water entry if the weepholes are protected.

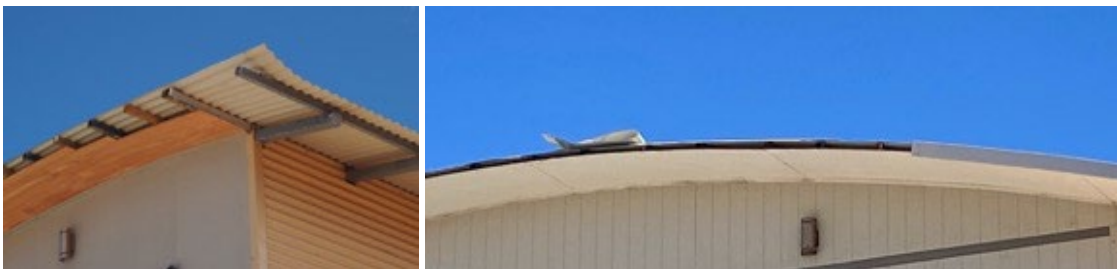
Water inside the building damages floor coverings, contents and, in some cases, can cause damage to wall and ceiling linings. A number of buildings that had been damaged in 2015 during Tropical Cyclone Olwyn (Boughton et al., 2015) were checked for their performance after Tropical Cyclone Narelle. The wind speeds were similar in these two events. The figures below show a number of buildings that experienced nearly identical damage in the two events. This indicates that in repairing the building after Tropical Cyclone Olwyn, only the obvious damage was repaired without addressing the point of entry of the water. In each of these pairs of photos damage after Tropical Cyclone Olwyn is shown on the left and damage after Tropical Cyclone Narelle is shown on the right.

Damage to a flashing that caused ceiling loss inside the building

AS 1562.1 requires flashing to be fixed to each face of the building with screws at closer centres than 500 millimetres. Fixings for any roof attachments should be designed to resist the appropriate wind actions.

In repairing elements damaged by water, it is important to not only fix the damaged linings, but also to address the point of water entry so that future events do not cause the same problem.

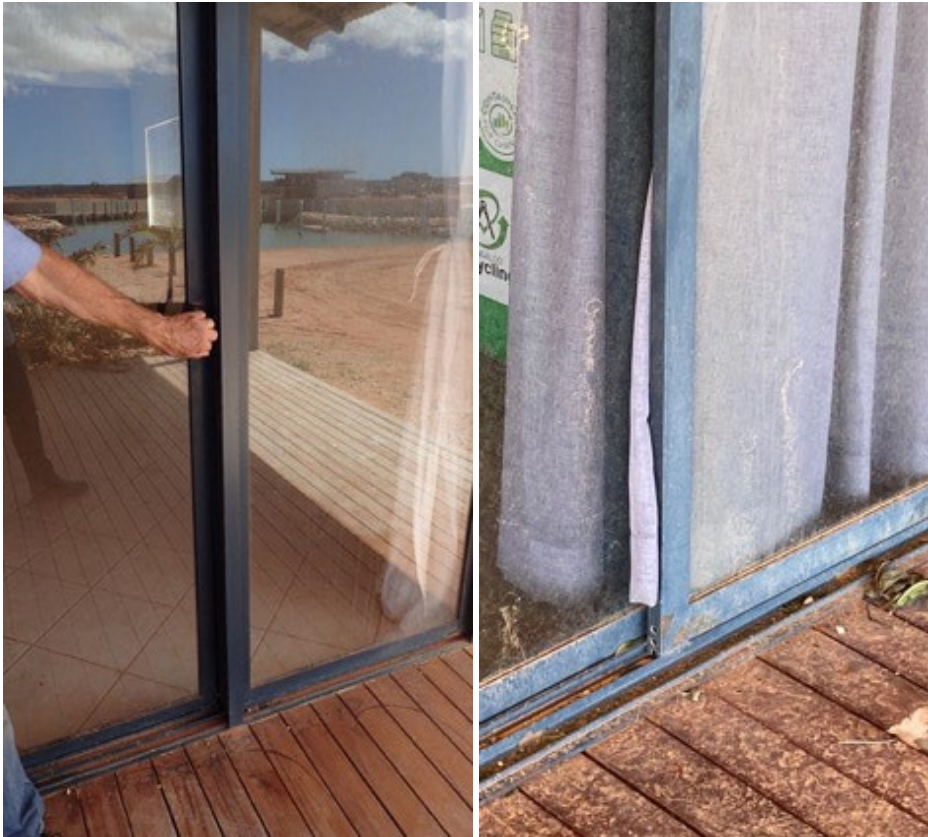
Bowing of lightweight sliding door causing water entry

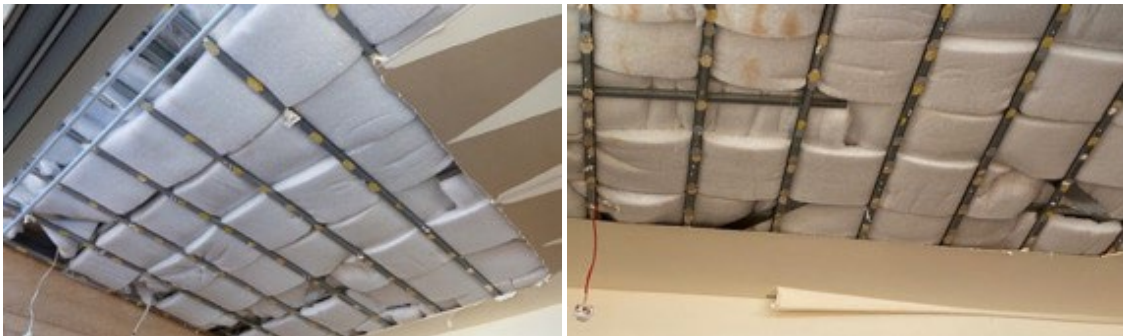
Ceiling loss behind ineffective apron flashing

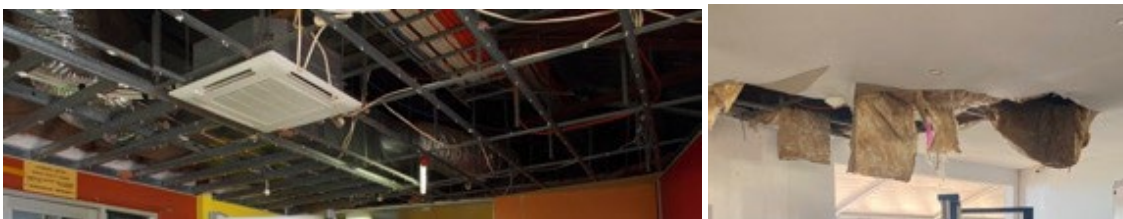
Ceiling loss under a vent in the roof space

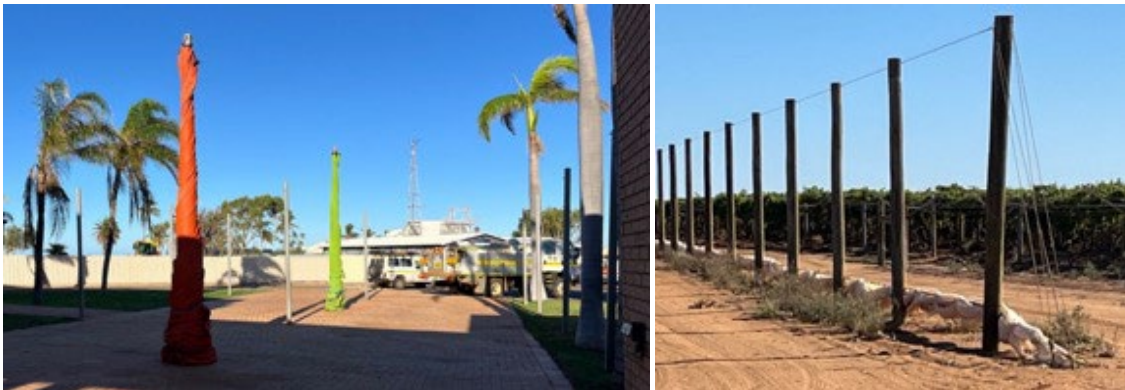
Both agricultural shade cloth structures and shade sails for protection of people from sun, survived where they were removed as shown below.

Survival of shade structures where they were rolled up or removed

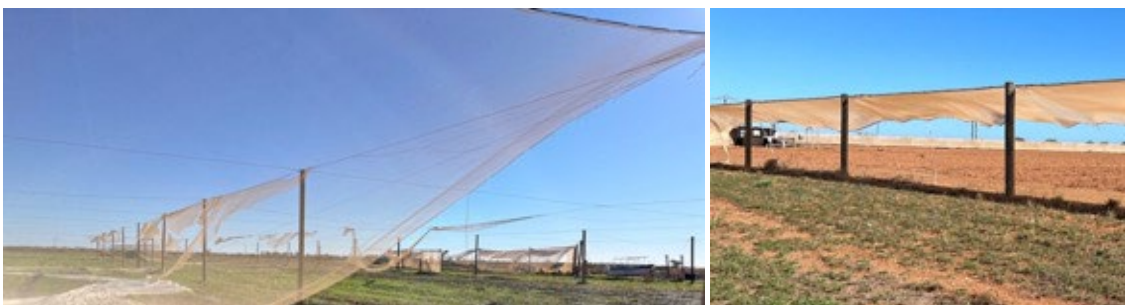
Where the shade cloth was not stowed, then there was significant damage to the structure so that it was no longer functional. Other methods must be investigated to make these structures resilient.

Damage to agricultural shade structures where they were not taken down prior to the event

Further research is required on preservation of agricultural shade structures in high winds.

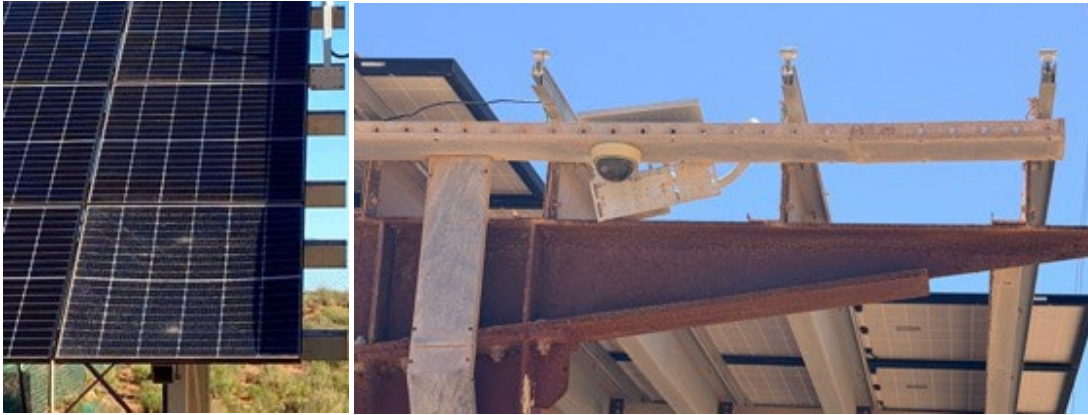
Ground-mounted panels failed by wind pressure causing either failure of the glass or crazing of the glass. In some cases, the camps anchoring the panels to the support structure failed by either loosening of the clamp or fatigue of the metal in the solar panel chassis.

Failure of ground-mounted solar panels, by failure of the glass and loosening of clamps

PV systems must be designed to resist the same wind actions as nearby structures. Select an appropriate importance level for solar panel installations based on expectation of functionality after severe events. Specify and install panels and support systems with appropriate wind ratings for the site.

Metal components of the support system should be tested for strength under repeated load and unload cycles.

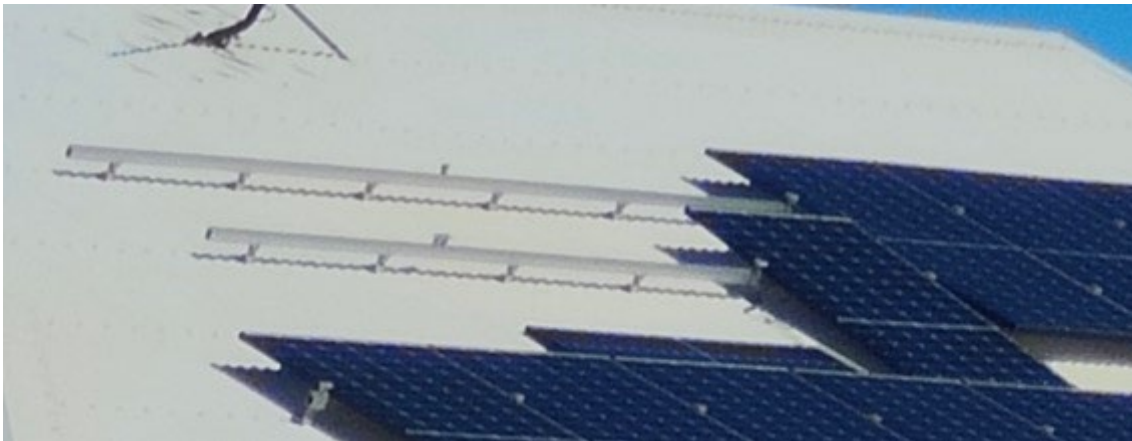
Roof-mounted panels also separated from the mounting systems by movement or failure of clamps. One panel was found 1.2 kilometres from its original position and other panels caused debris impacts into nearby structures.

Clamp failures allowed panels to move on the roof and be blown off the roof
