# Managing earthquake risk

Unreinforced Masonry Building Database

#### **Dr Hossein Derakhshan**

Natural Hazards Research Australia Queensland University of Technology

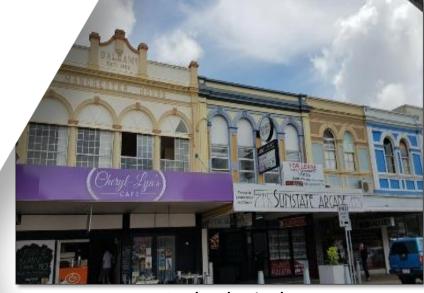
Arched windows
Ornamental details

- → Visual aspects that help detection
  - Whole of façade view
  - Arched windows
  - Raised parapets
  - Ornamental details
- → QUT computer vision team
  - Al Training, detection, and quality controls

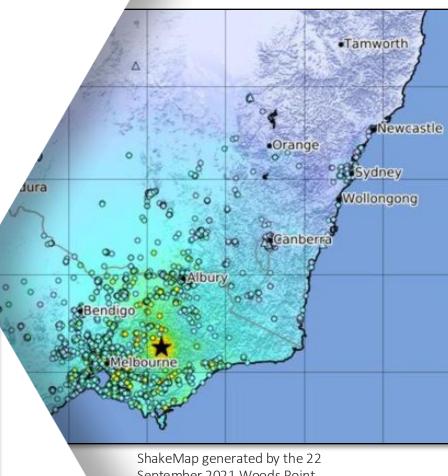
ShakeMap generated by the 22 September 2021 Woods Point earthquake (Geoscience Australia 2021)

Data libraries integrated with hazard reports, e.g. ShakeMap

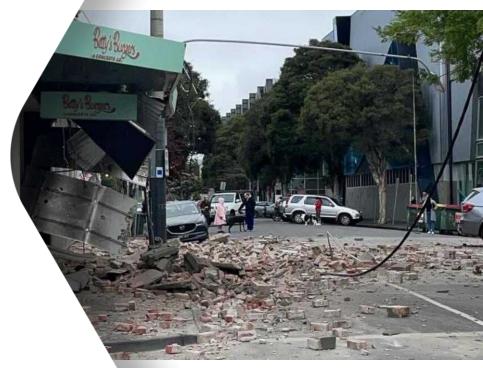
Betty's Burgers Building damage in Woods Point earthquake; Credits: Gemma Bateman
