**INVESTIGATION OF  
BUSHFIRE ATTACK MECHANISMS  
RESULTING IN HOUSE LOSS IN THE  
ACT BUSHFIRE 2003**

**Bushfire CRC Report**

*Raphaelae Blanche and Justin Leonard*

**April 2005**

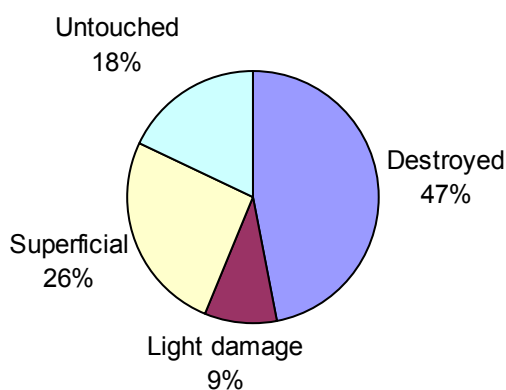
Four main levels of damage were used for the investigation (see Figure 7):

Figure 7. Degree of house damage

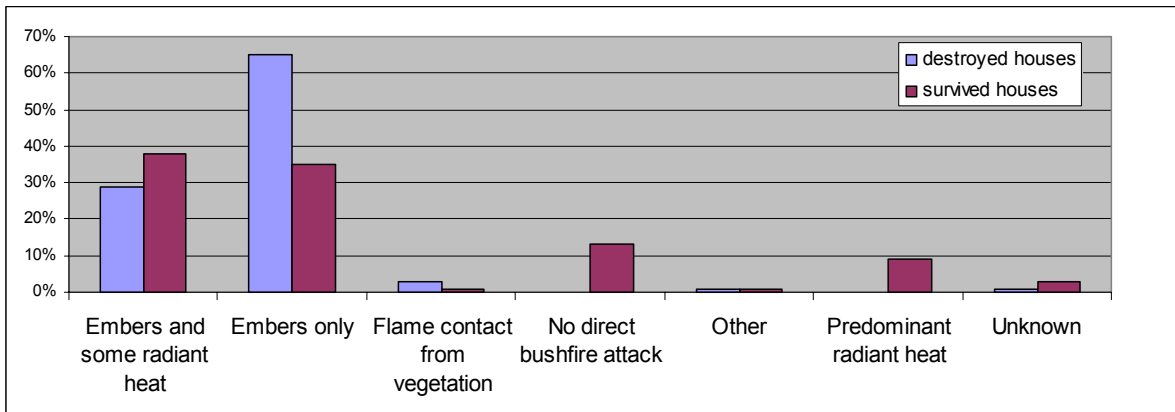
Analysis of the data indicates that no houses in Duffy were directly impacted by flames from the fire front itself. In 50% of cases, the bushfire attack mechanisms were via embers only, and 35% were via ember and some radiant heat from surrounding isolated vegetation or other structures (see Figure 8). The houses that survived included all those superficially or lightly damaged, and those that were untouched. Radiation from the main fire front was not sufficient to cause ignition or direct damage to the structures; however, it is likely to have played a role in increasing the likelihood of flame propagation as a result of ember attack. Convective heat (hot gases from the flame front) is also likely to have contributed to increased risk in a similar way.

**Figure 8. Mechanisms of bushfire attack**

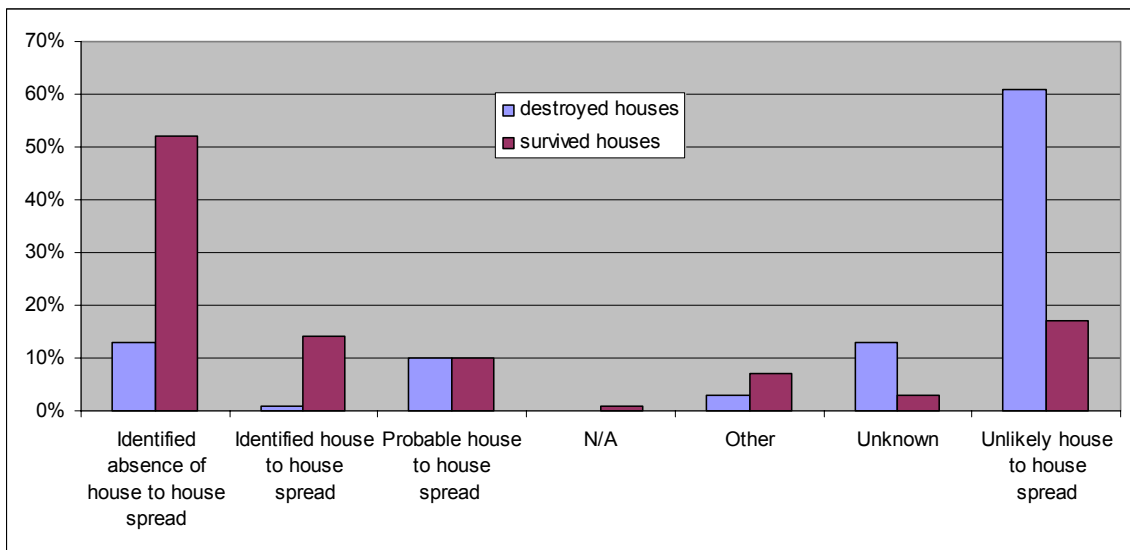
House-to-house ignition played an important role after the passage of the fire front in Canberra; the ignitions were due to burning debris from house on fire, direct flame contact or radiant heat (see Figure 14).

**Figure 14. Identification of house-to-house fire spread in Duffy**

The initial vegetation and structural fires in Duffy created an even more concentrated and enduring ember attack for those homes further downwind. Some of the structural fires provided direct flame attack and radiation impact on adjacent structures also. These impacts persisted for hours rather than the few minutes it takes for a flame front to pass. This effect was exacerbated by the placement of relatively large houses on medium sized blocks, and the presence of timber fences and vegetation between the closely orientated structures (see Figure 16). For further detail on vegetation and other structure impact, see Section 8.

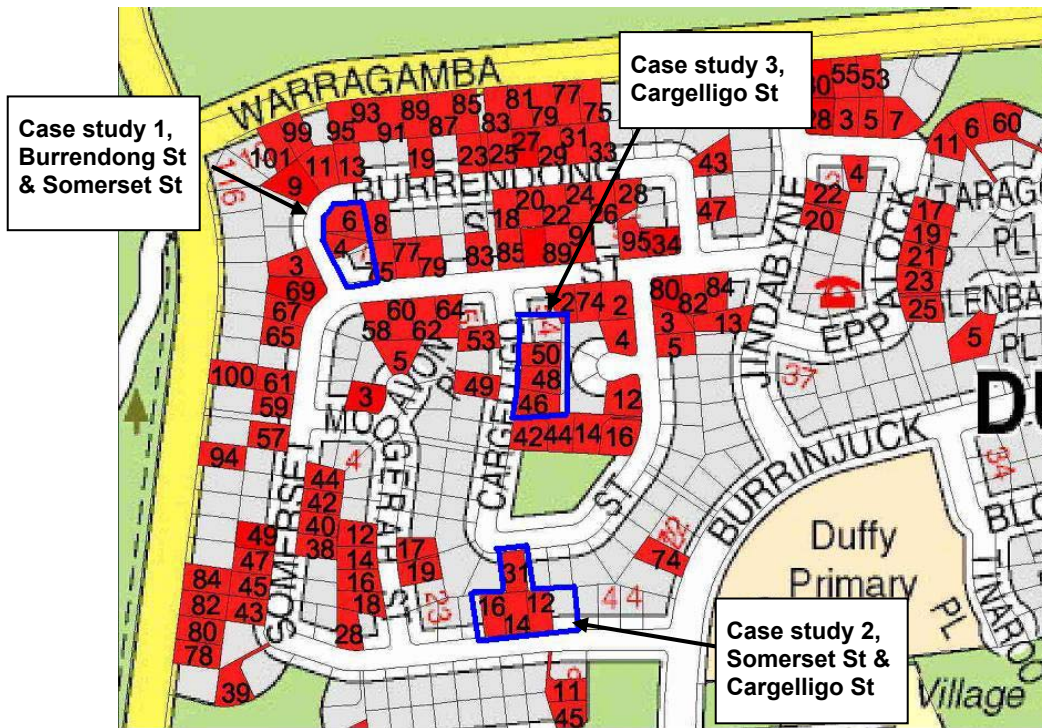
The following case studies identify house-to-house ignitions that resulted in house loss in the surveyed area (see Figure 15).

Figure 15. Location of case study houses

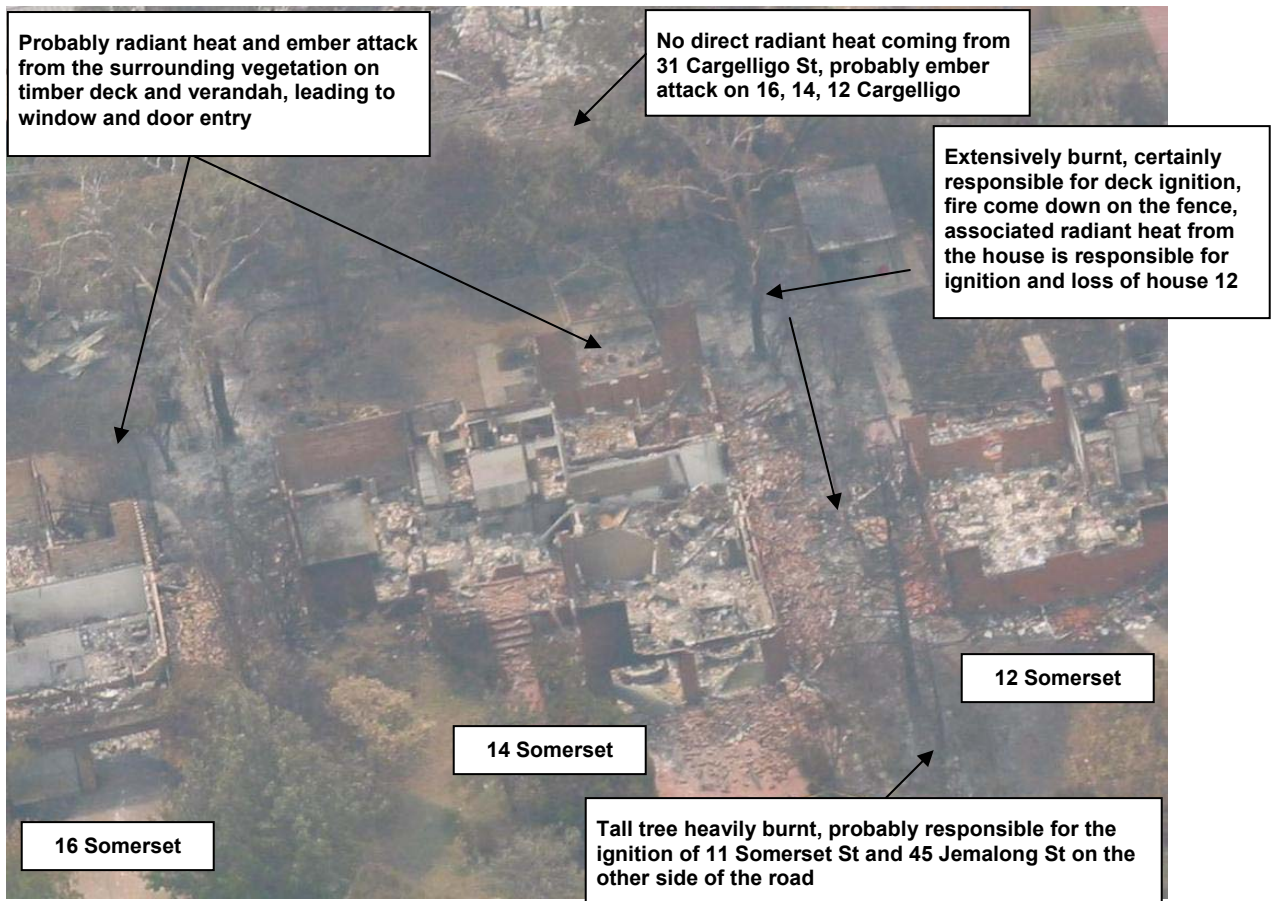
Figure 19. Detail of 14 Somerset St

These four destroyed houses were deep within the suburb and surrounded by surviving houses. It is highly likely that an ember attack ignited 31 Cargelligo St, which then become the predominant source of fire attack on the area of 14 Somerset St. House-to-house fire spread from 14 to 12 Somerset was reported during the survey, and ground-based photo evidence identifies that fire spread involving ground fuels and secondary elements between 14 to 16 Somerset, as well as from 31 Cargelligo to 16 Somerset. Figures 19 and 20 provide further visual evidence of these mechanisms. The occupant of 10 Somerset elected to stay, he mentioned that he was involved in extinguishment activities from ember attack and burning fences associated with the structural fire at 12 Somerset, these activities may have reduced the risk of further house ignitions.

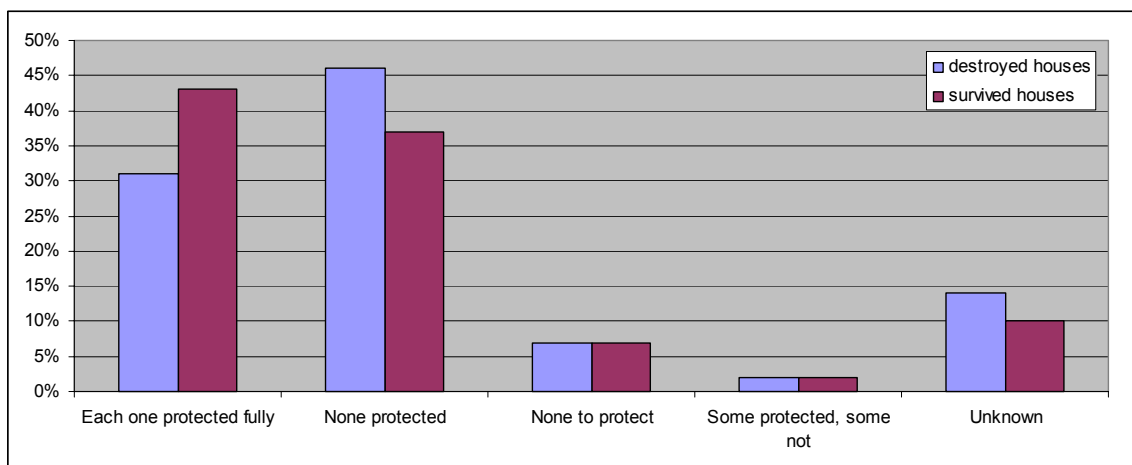
Data collected in the investigation shows that only 31% of the destroyed houses have vents fully protected (see Figure 29).

**Figure 29. Protection of vents**

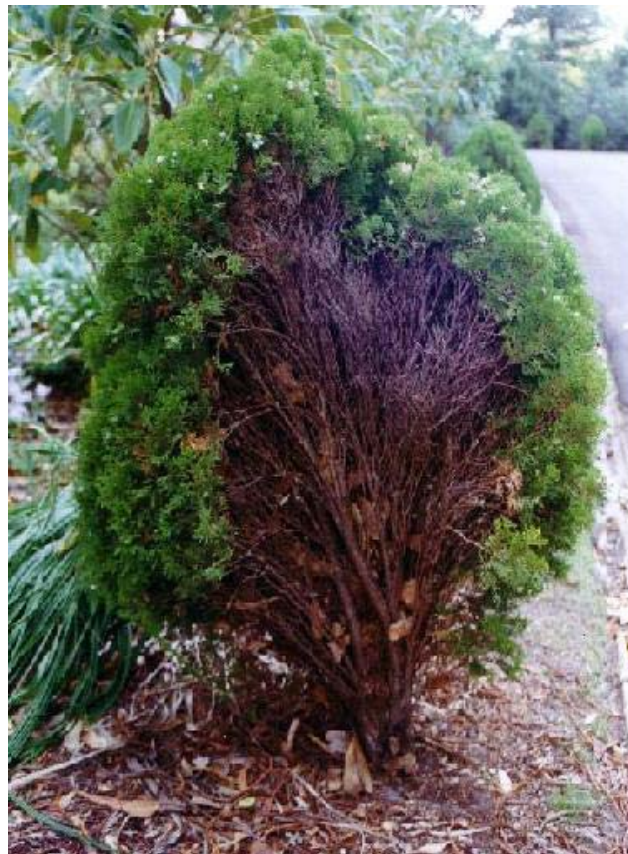
Certain types of vegetation are particularly susceptible to fire, for example cypress trees produce large quantities of dead material, and the intensity at which they burn may adversely impact on structures in the vicinity (see Figure 42 to Figure 44). The performance of this vegetation type is a direct observation of the survey initiative.

**Figure 42. Cypress tree (large quantities of dead material inside the tree, example not in Duffy area)**

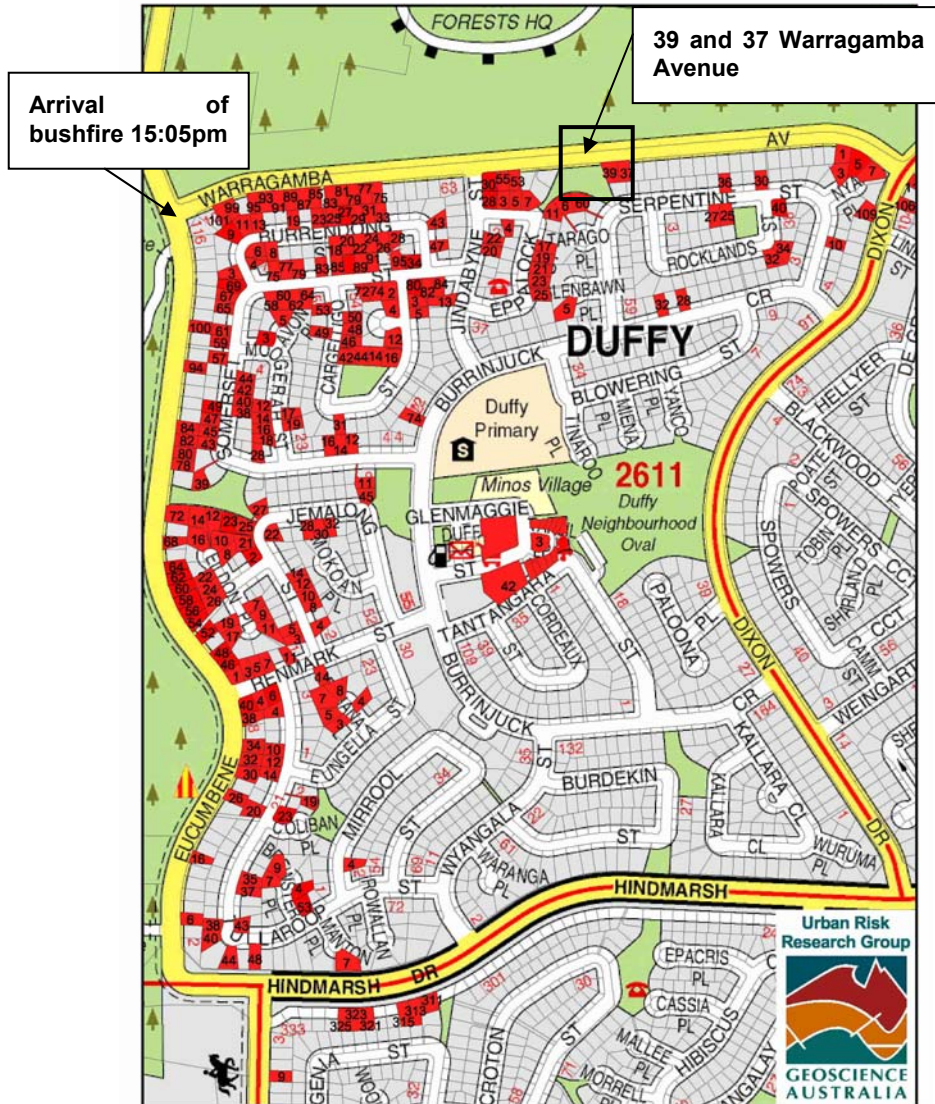
Phil Cheney mentioned that the fire reach the corner of Warragamba Ave and Eucumbene St Duffy at 15:05. By 15:45 the fire had entered the suburb of Duffy between Dixon Drive and Hindmarsh Drive (see ‘Origin and Development of the Bushfires that Spread Into the ACT, 8–18 January 2003’ by N.P. Cheney, Principal Research Scientist, CSIRO Forestry & Forest Products). See Figure 51 for details.

Figure 51 Fire passage in Duffy suburb
