# Tropical Cyclone Narelle: Insights on resilience

Understanding damage, vulnerabilities and future risk to buildings in Wind Regions D, C, B2 and A

**A/Prof Geoff Boughton<sup>1</sup>, Dr David Henderson<sup>1</sup>, Simon Ingham<sup>1</sup>, Dr Bruce Harper<sup>2</sup>**

Natural Hazards Research Australia  
ISBN: 978-1-923057-72-2  
Report number: 89.2026  
June 2026

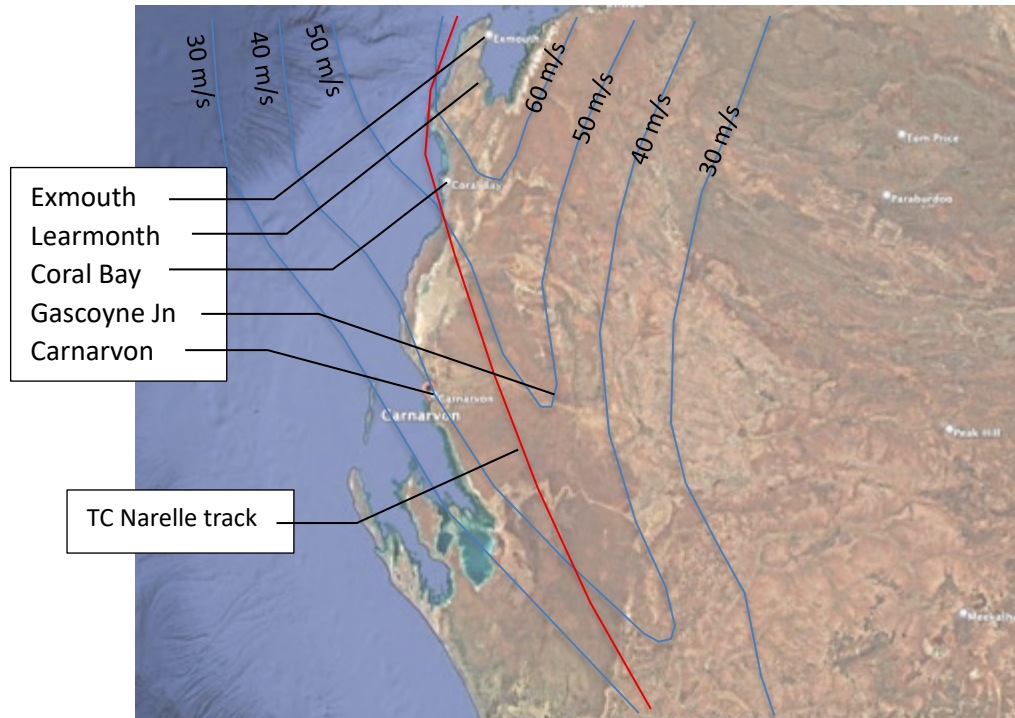
0.2 second wind gusts (Compatible with AS/NZS 1170.2)

The estimated wind speeds in the inspected region were between 60% and 70% of the design wind speed for houses. Wind loads are calculated from wind pressures that are based on the square of the wind speed, so the loads that the buildings in this area had to resist are less than 50% of the required design load the building components).

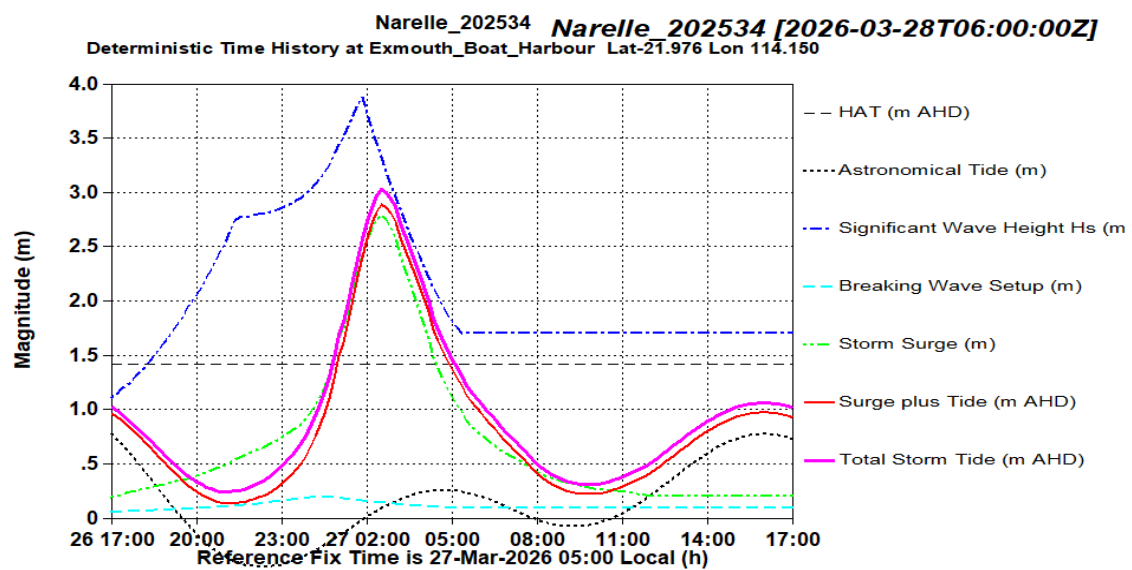
SEA Tide modelling of storm tide at Exmouth
